## Mock Inspection Report

9 Reynolds Place, Palm Coast, FL, USA

Mar 2, 2025

Performed by **David MacCuish**

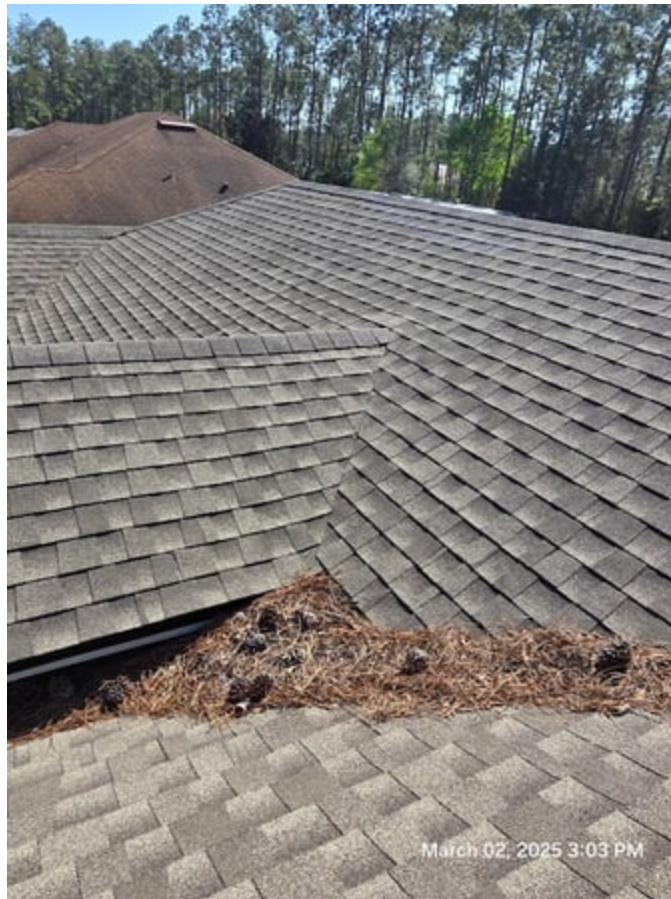
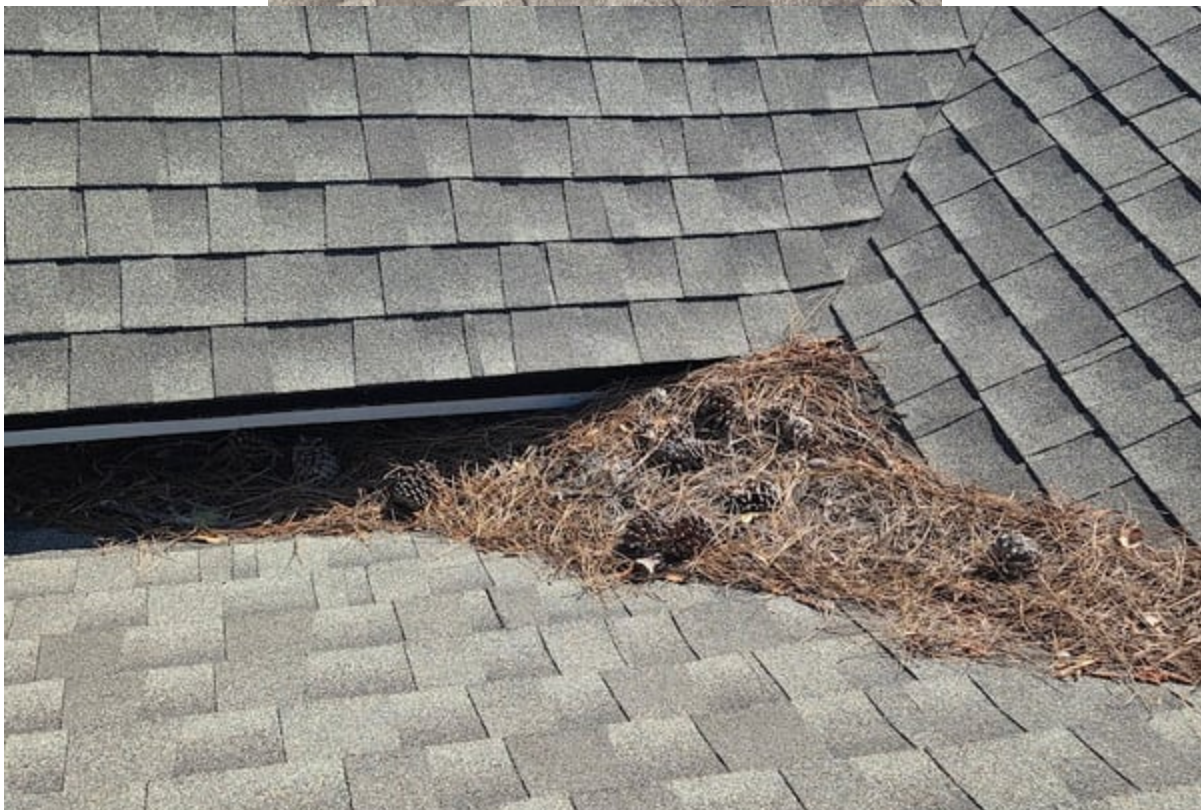
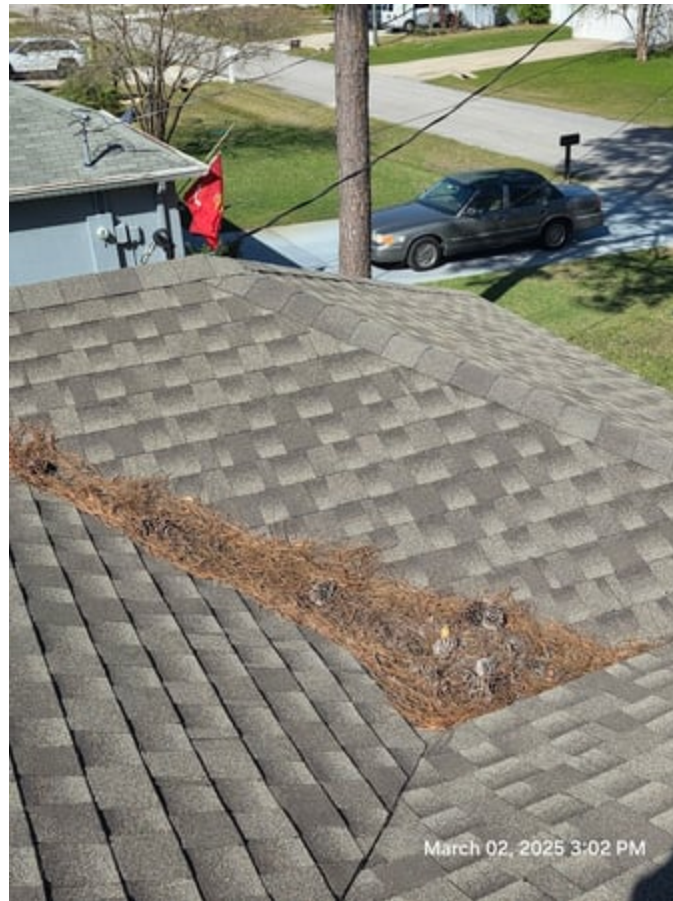
Minor Defect

Roof is a 5:12 pitch, architectural shingle roof. County records show permit reroof in 2022. "Tree litter"/organic materials built up in the valley. The concern with the buildup vegetation on the roof is that it retains moisture and leads to premature aging and deterioration of asphalt shingles. Recommend removal of debris.

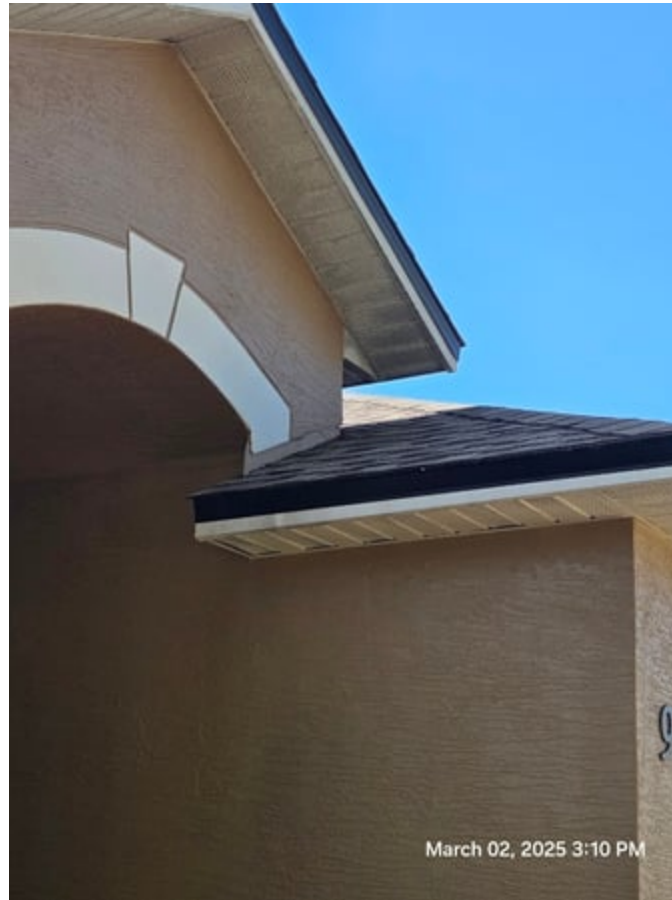
Not Inspected | **Not Present**

Recommend the installation of gutters to prevent runoff at front door

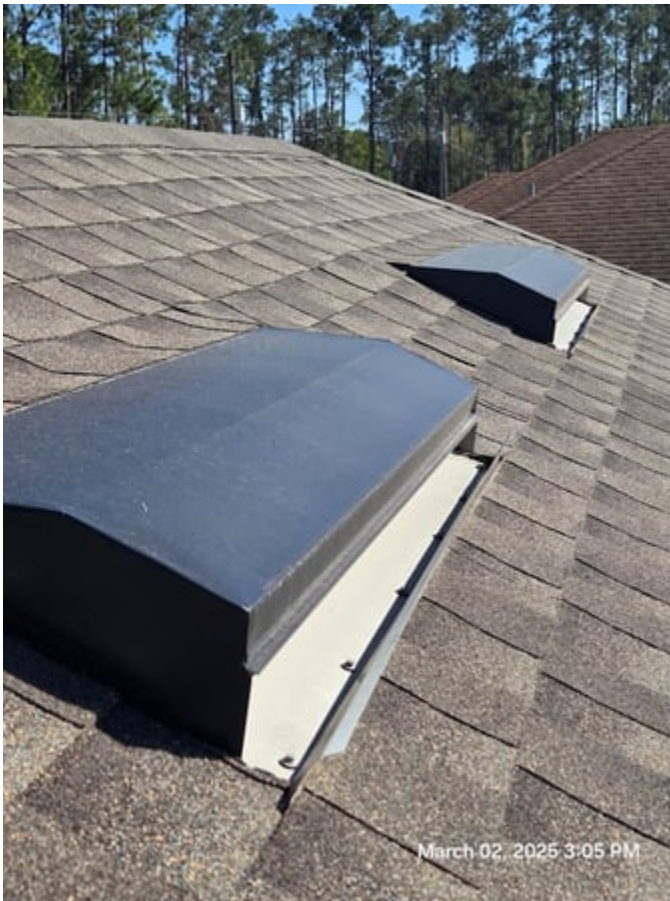
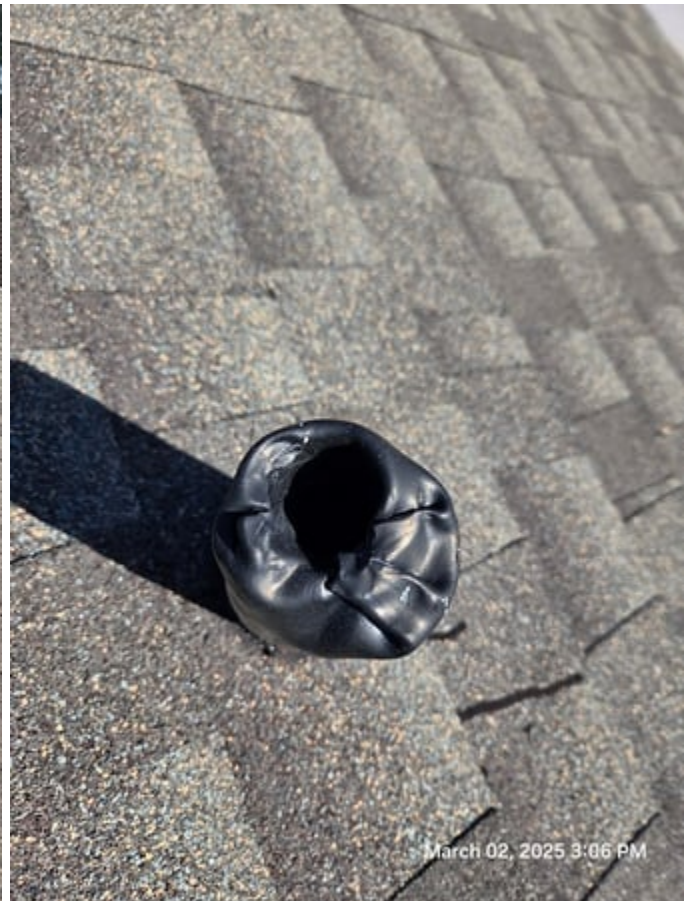
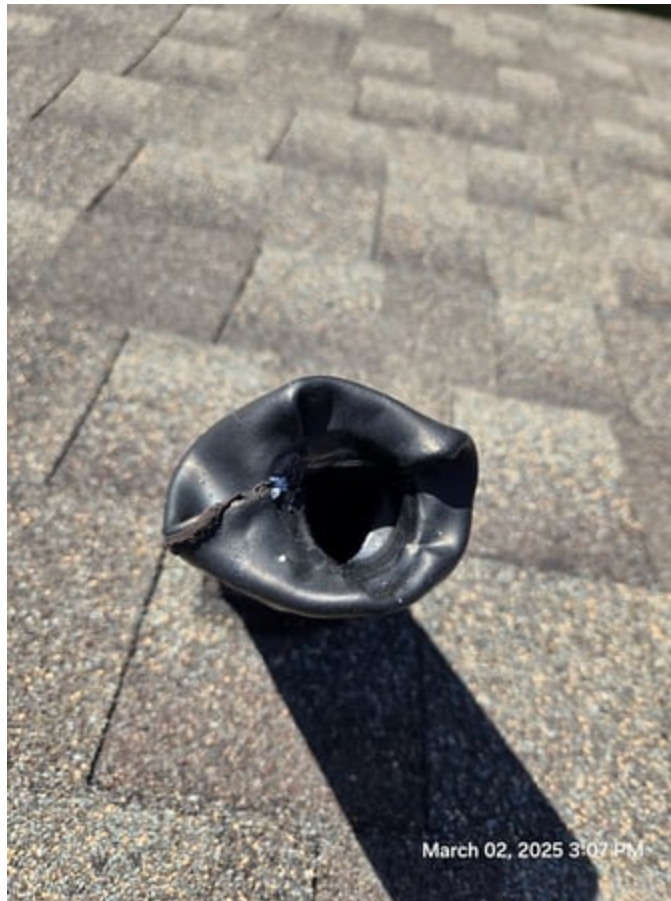
**Material Defect**

Venting by off-ridge roof vents appeared properly attached Lead Flashing over vent stack pipes. Vent pipes are partially obstructed by the flashing. Airways on vent pipes cannot be hindered, or obstructed. Recommend cut back of flashing over the stack by a certified roofing specialist.

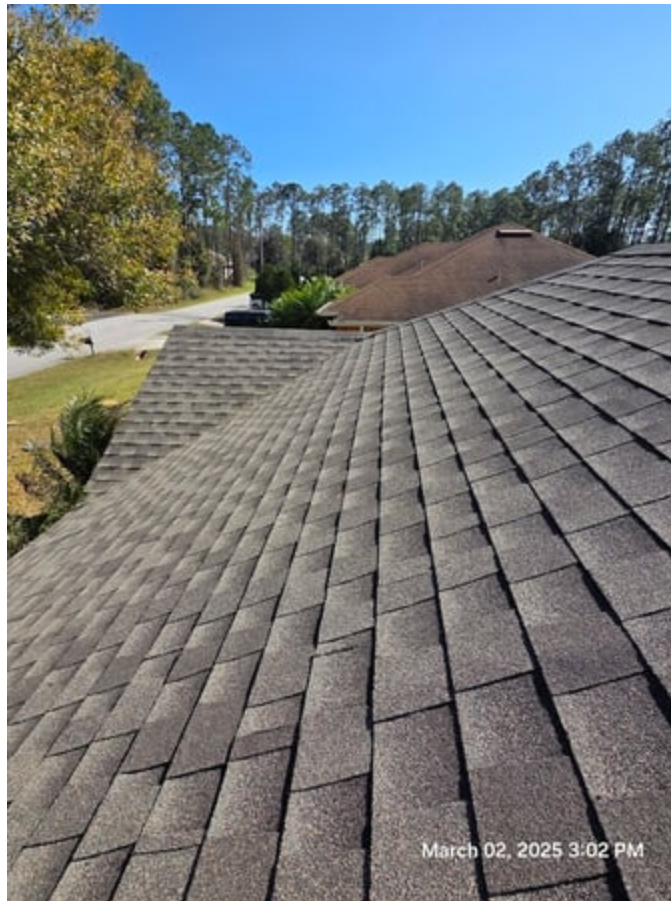
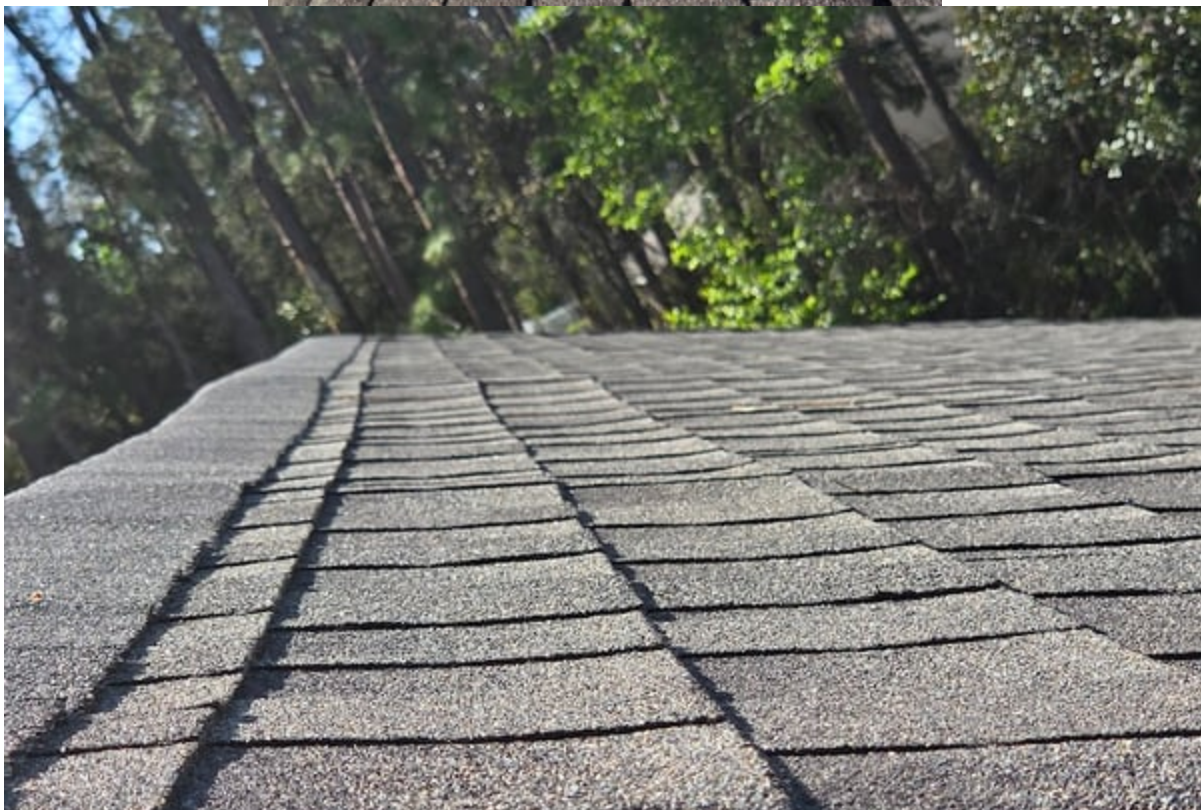
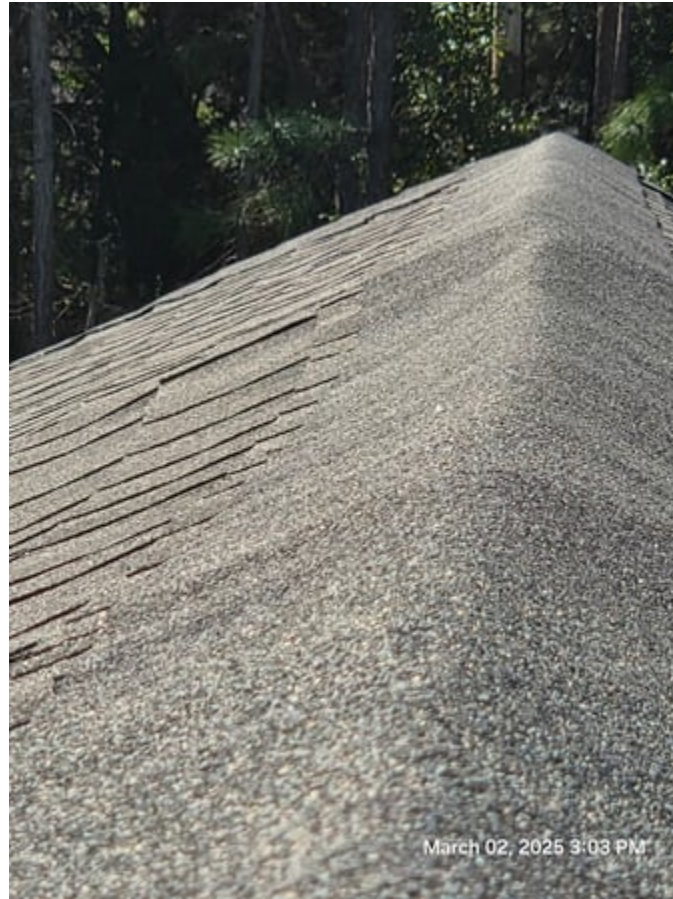
**Minor Defect**

"Buckling" occurs when shingles warp or bend, often caused by improper installation or underlying roof deck issues.

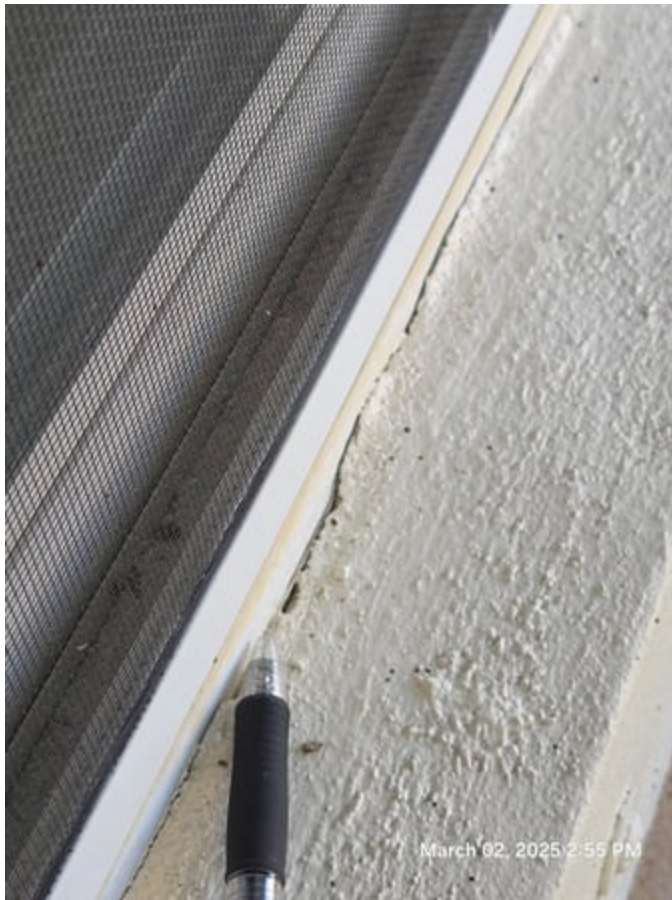
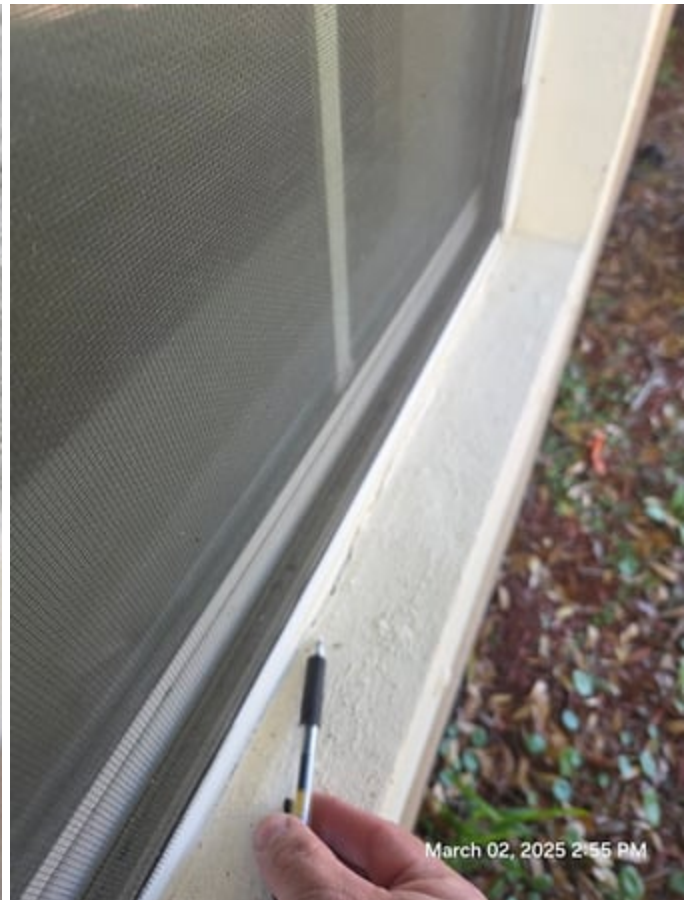
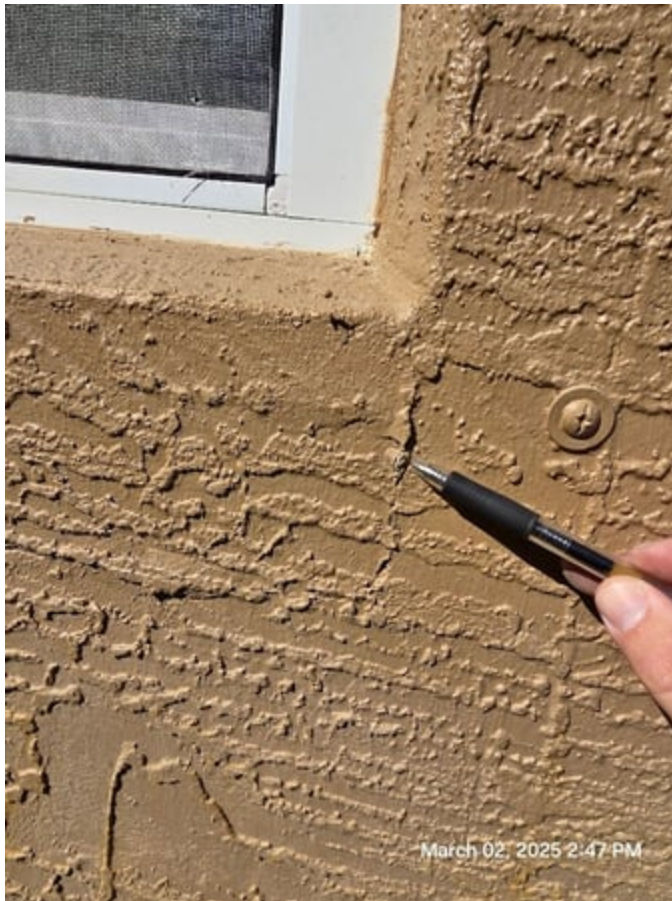
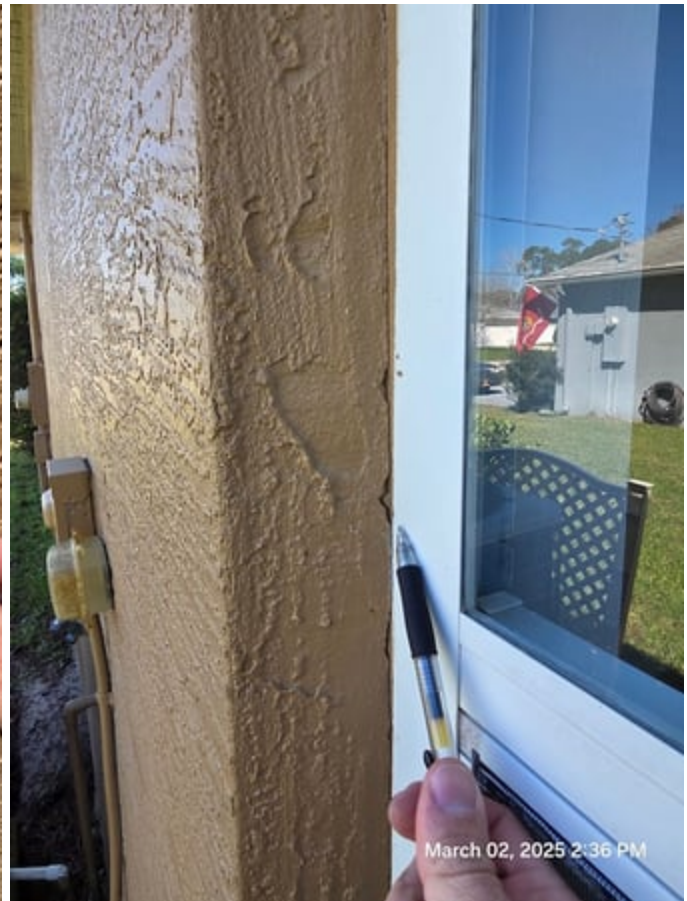
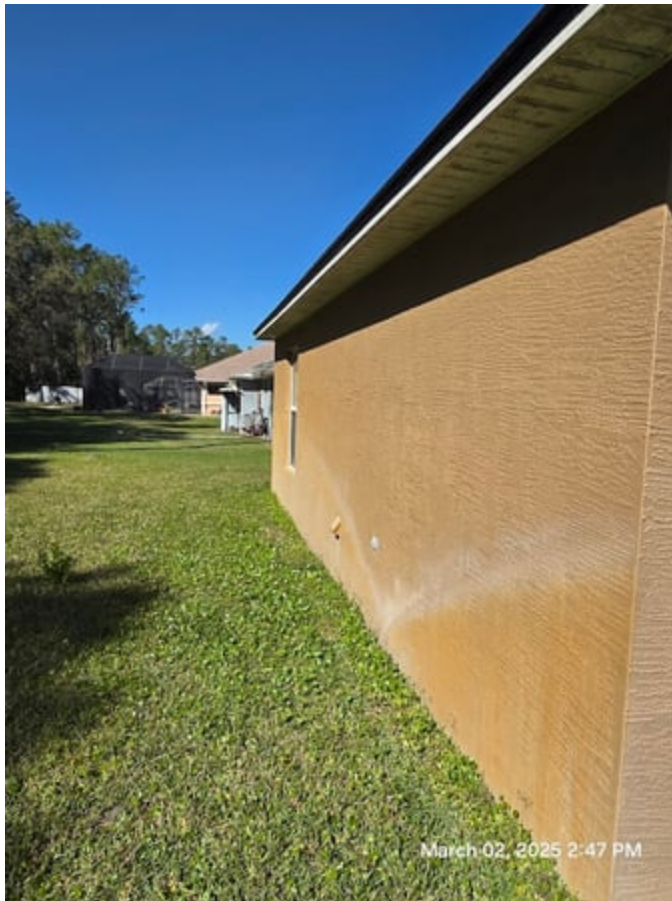
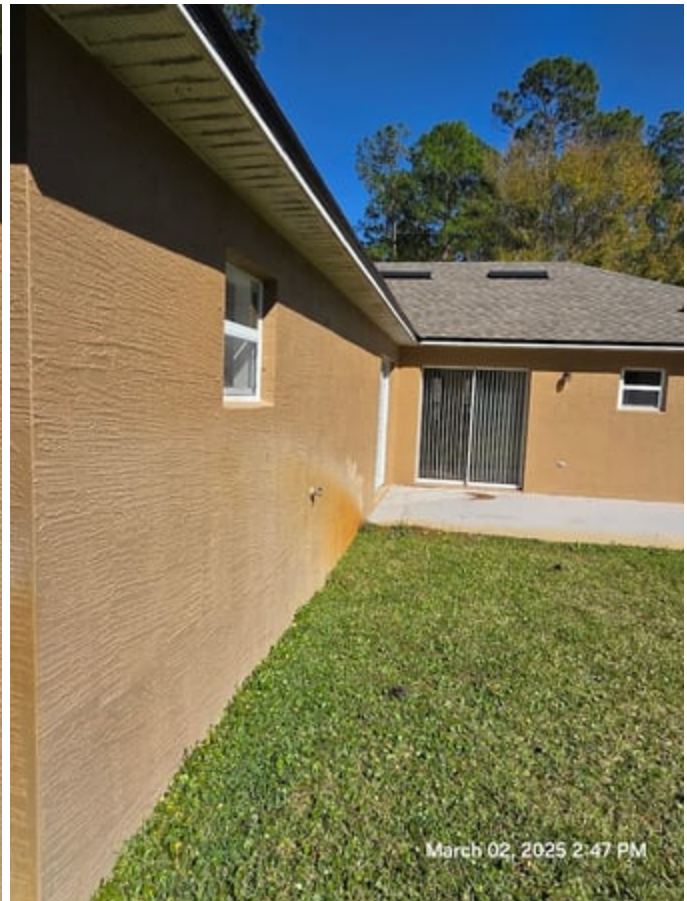
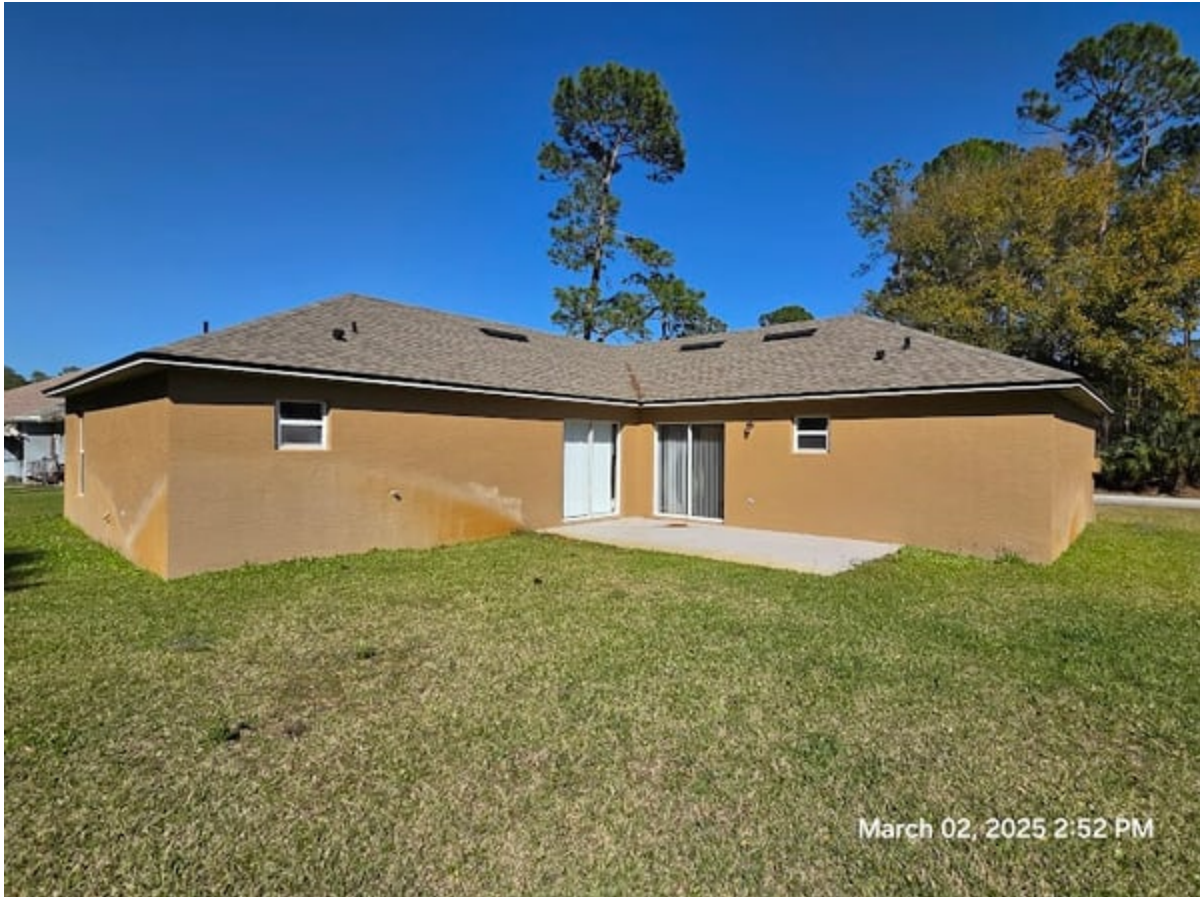
Major Defect

Areas of cracking observed around various portions of the exterior window casings. Staining of walls by sprinkler overspray. This can result in water intrusion into the home

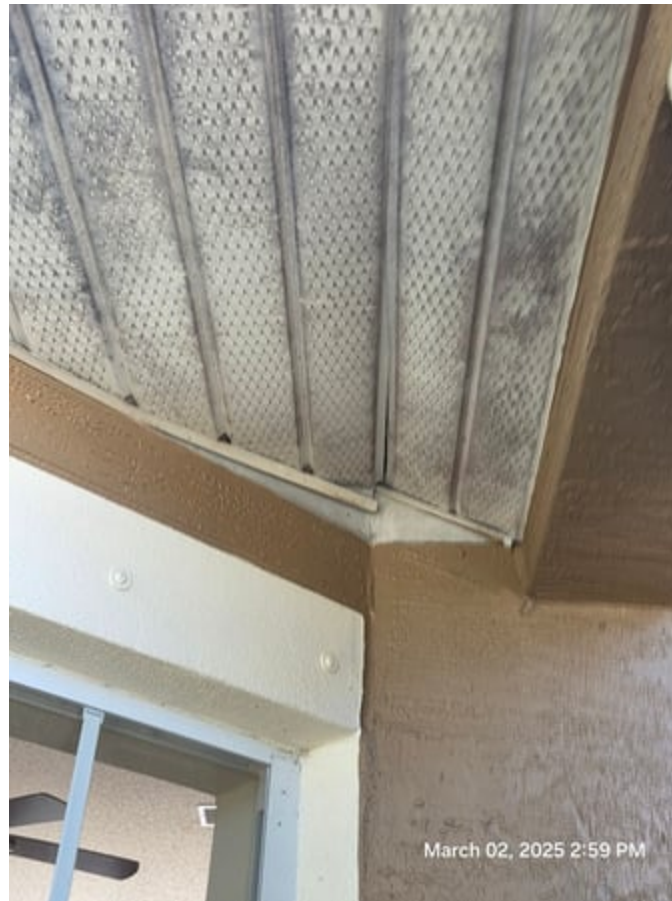
**Material Defect**

Soffit damage by front door.

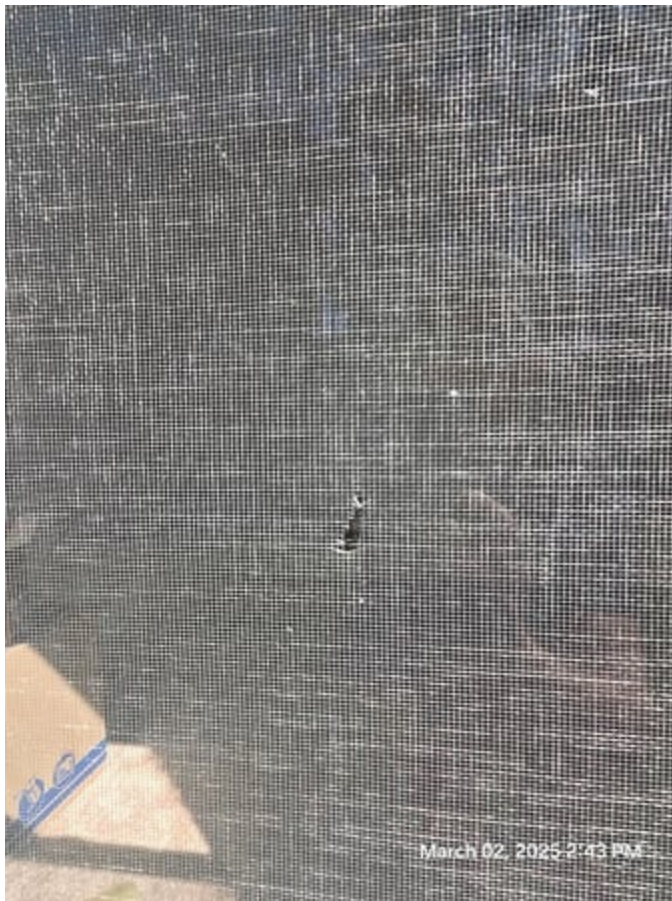
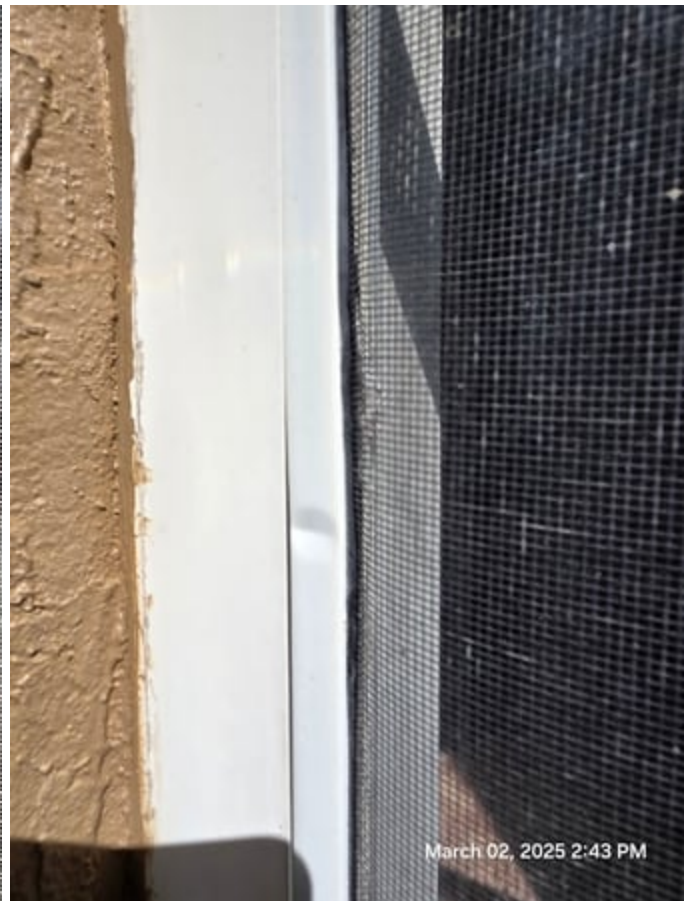
Material Defect

Windows are single pane construction grade. Damage to screen on rear of house.

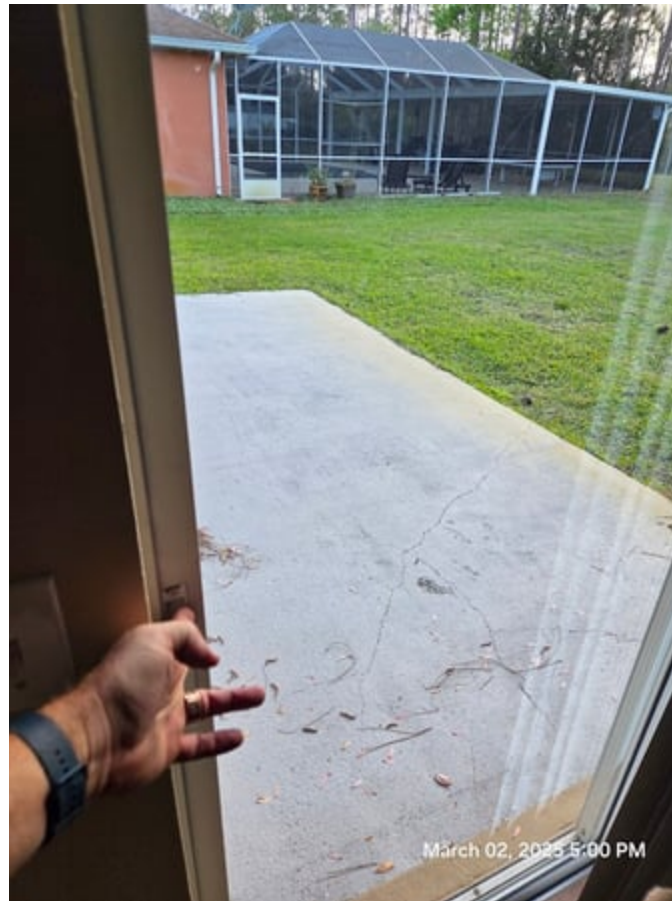
**Material Defect**

Sliding glass door was hard to open. Further evaluation is recommended.

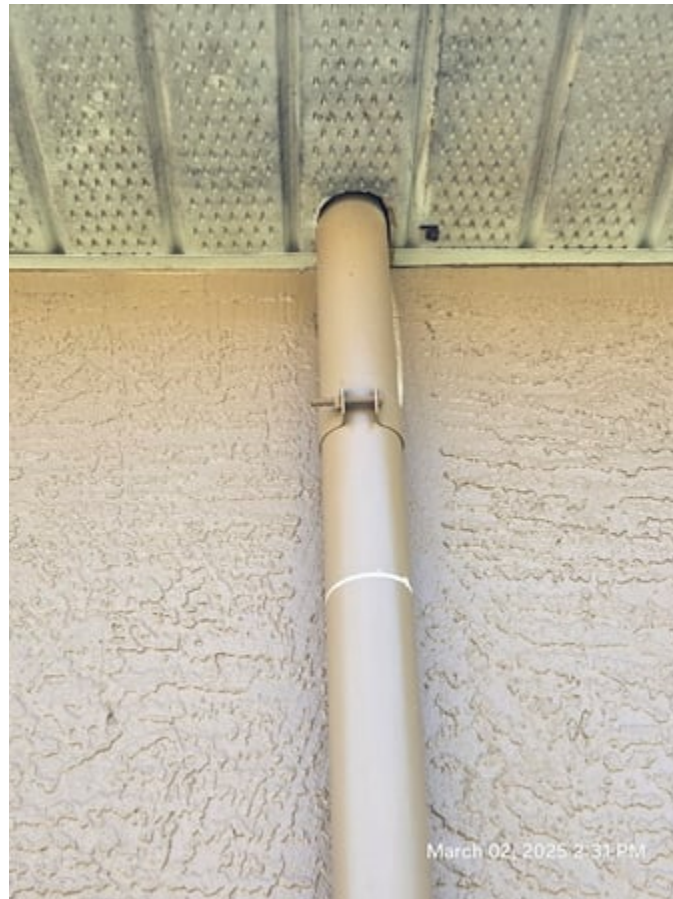
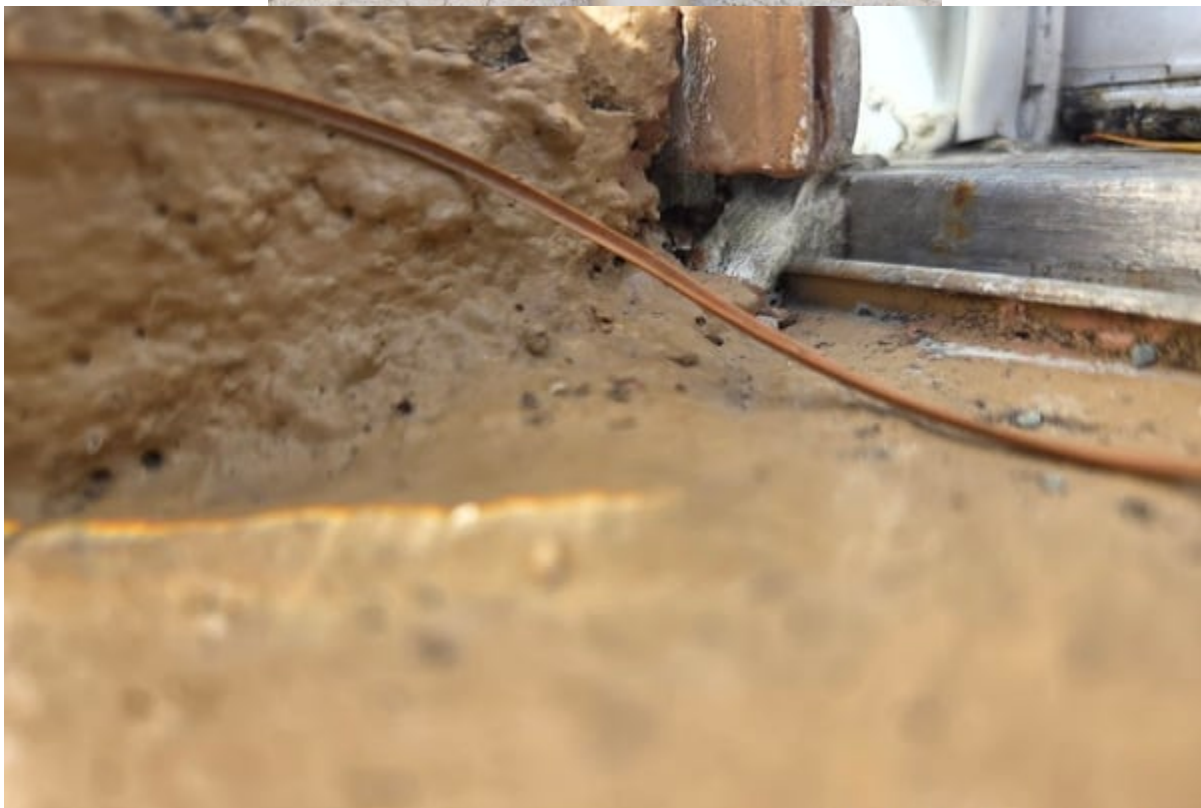
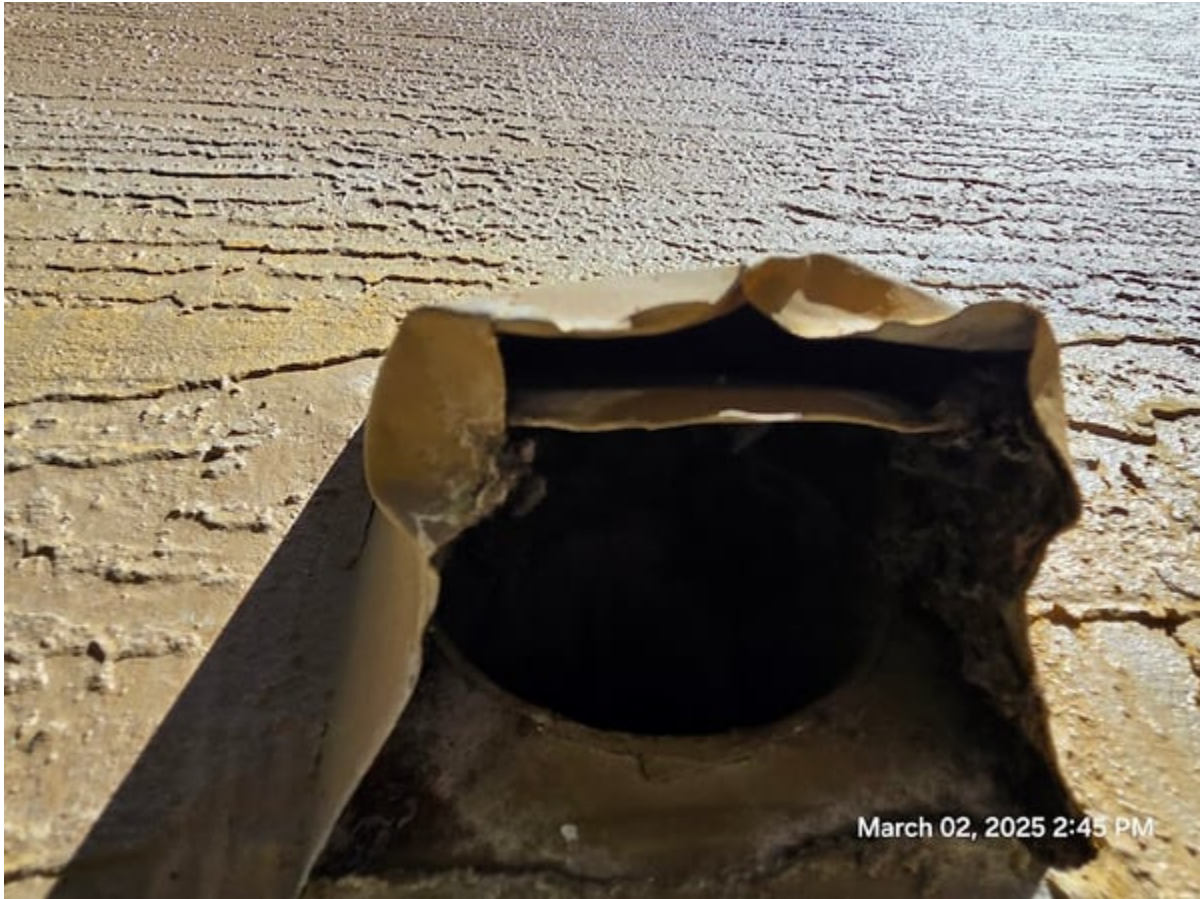
**Minor Defect**

Seling needed around service mast. Openings allow for insect passage. Cracking observed in the West facing sliding glass door bottom corner. Sealing recommended. Dryer exhaust back draft damper stuck in the open position. Further evaluation is needed by a qualified appliance technician.

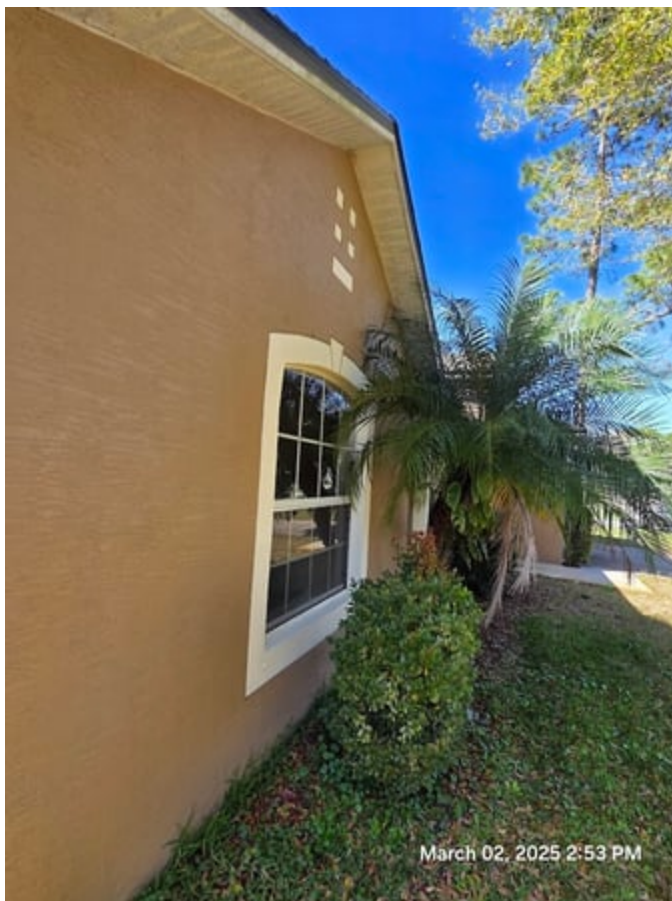
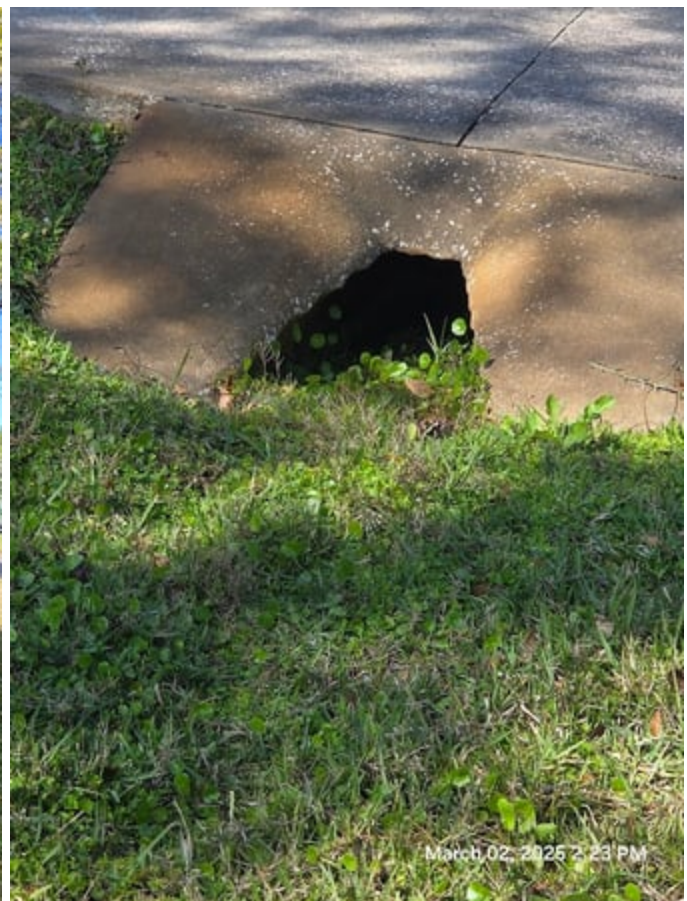
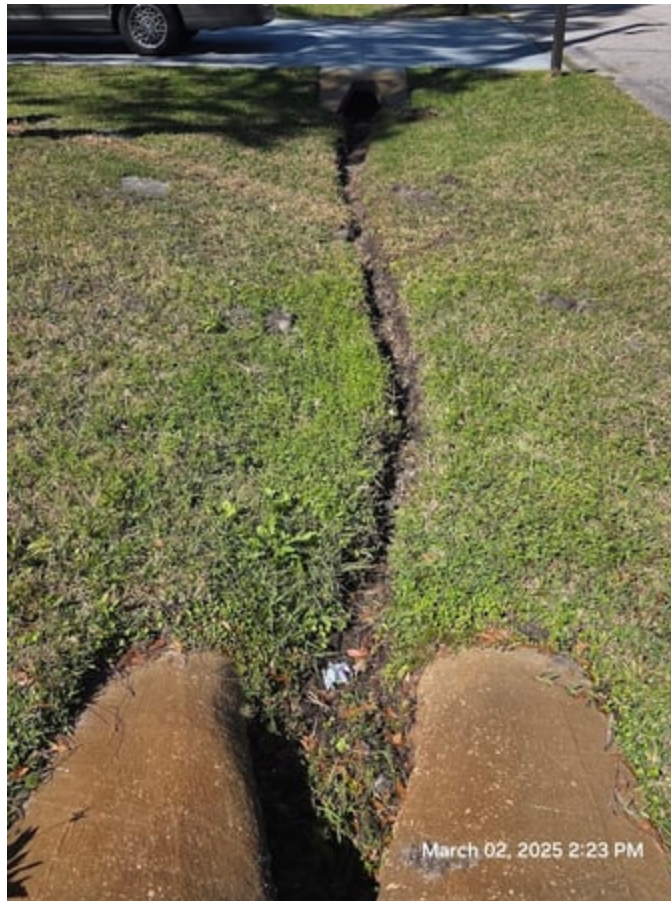
**Material Defect**

Vegetation in contact with home. This creates wear on the exterior portions of the home and pathways for insect travel into the structure. Recommend cut back of tree and bushes. Driveway culvert overgrown with vegetation and grass. Recommend contacting the city of Palm Coast for assistance.

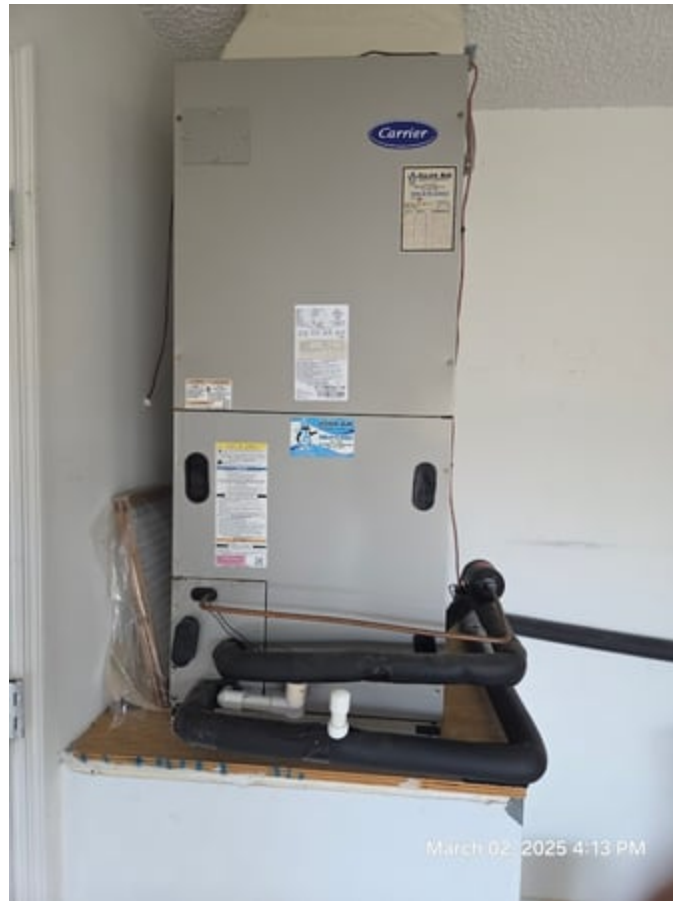
**Minor Defect**

Clogged filter. Recommend replacement. Operated as expected.

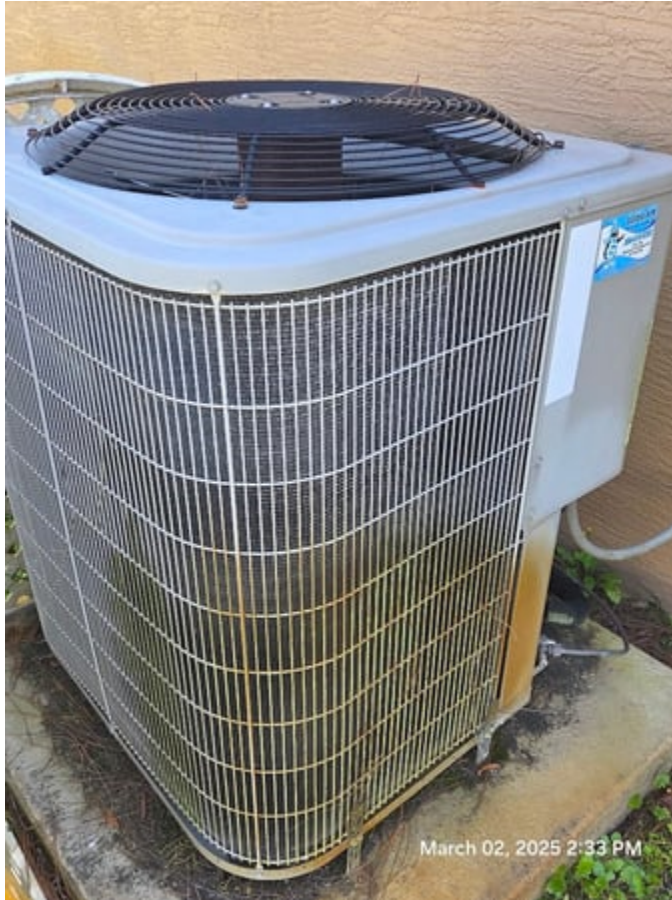
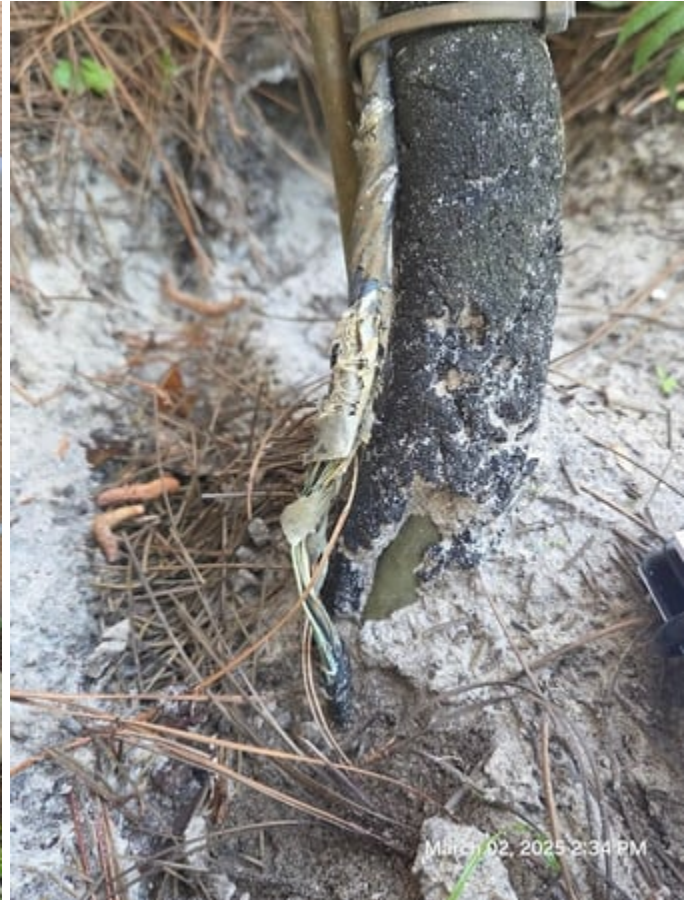
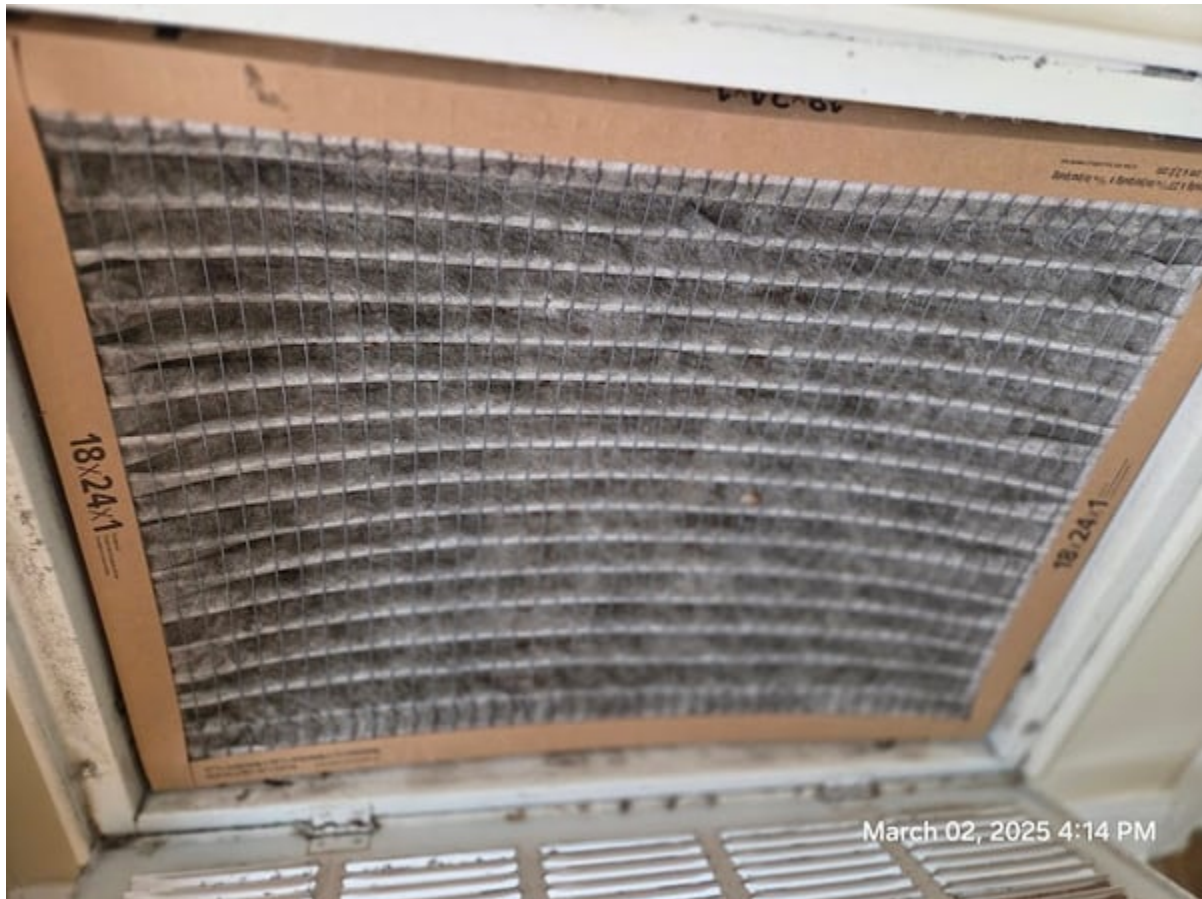
Material Defect

Frayed electrical wire to outside condenser unit. Clogged filter
