## Mock Inspection Report

9 Reynolds Place, Palm Coast, FL, USA

Mar 2, 2025

Performed by **David MacCuish**

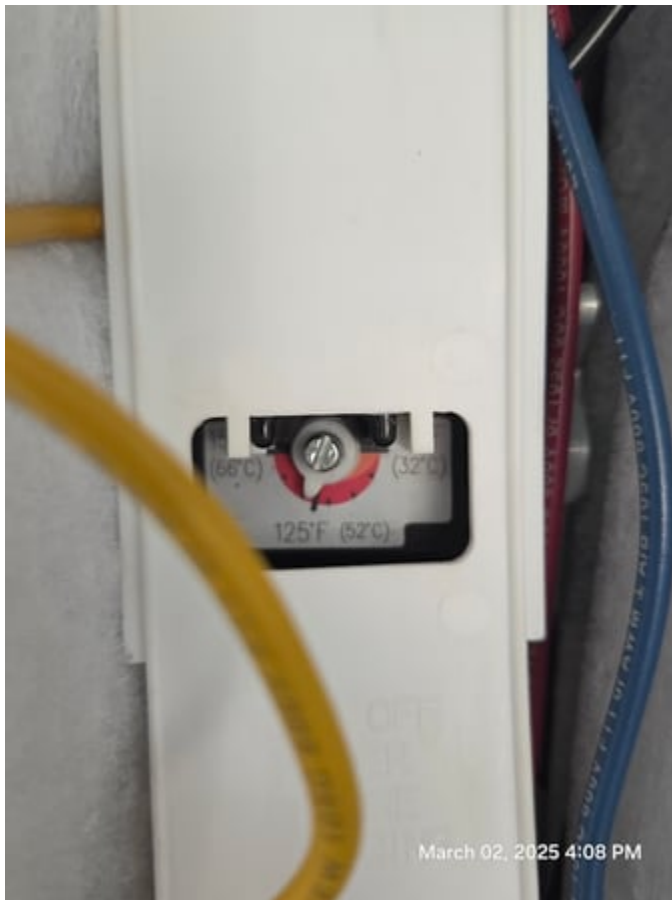
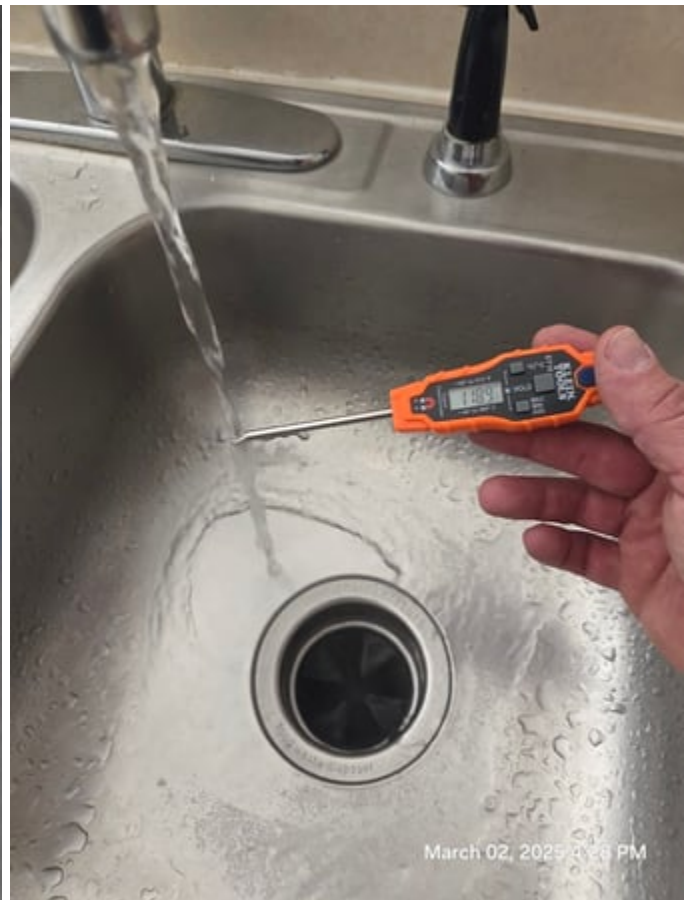
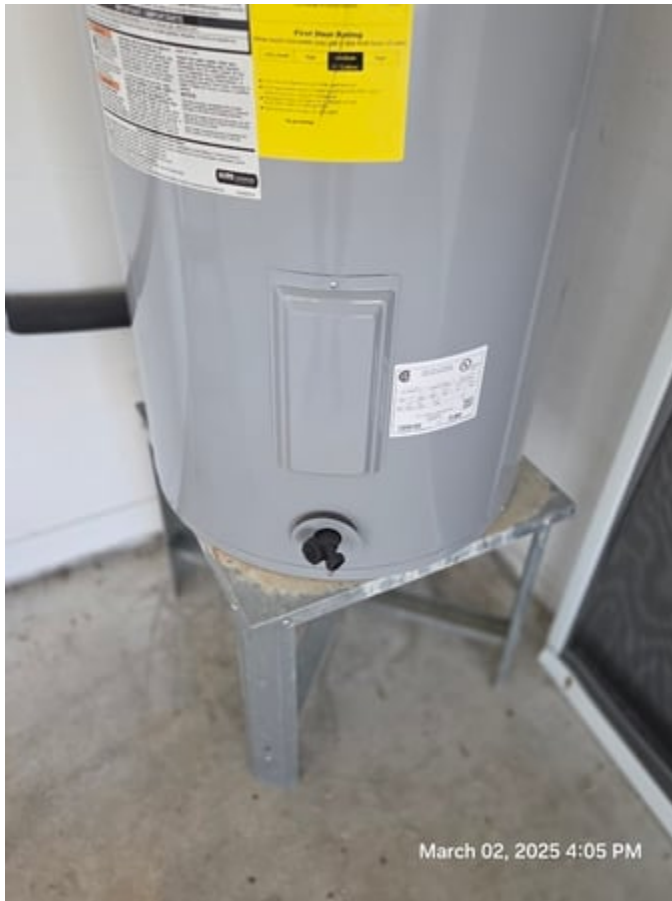
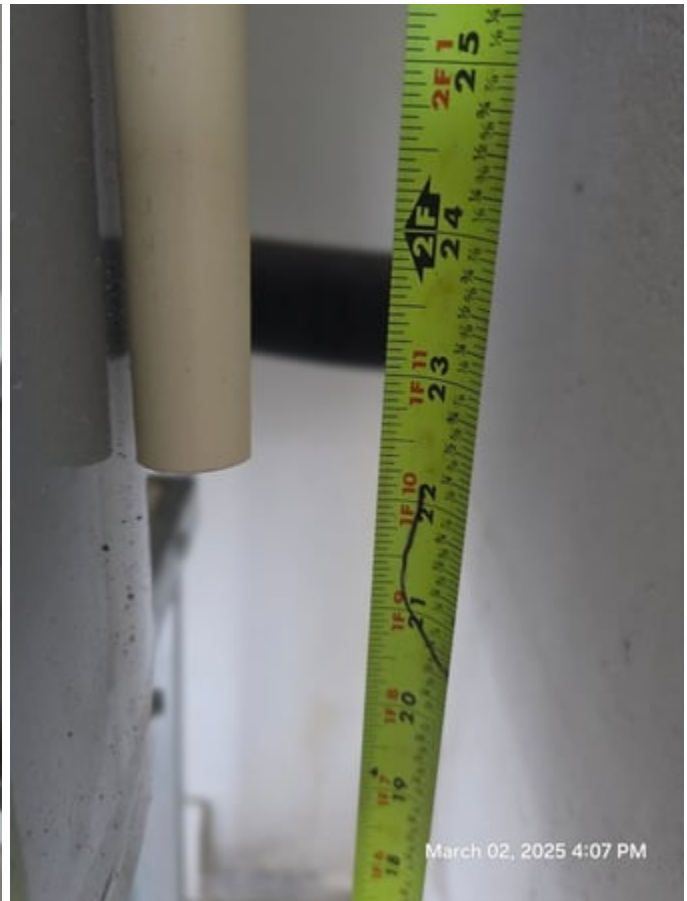
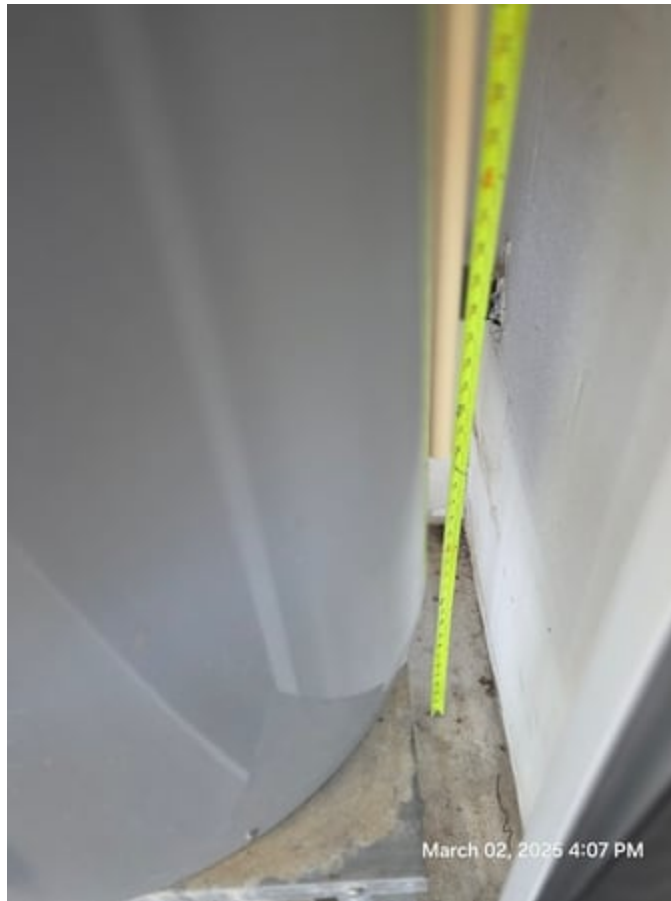
Material Defect

Hot water was set at 125 degrees F. Hot water heater located in garage. Missing water heater drip pan. Recommend installing drip pan as required. TPr valve discharge tube needs to exhaust potentially harmful temperatures to a safe location within 6 inches of the foundation.

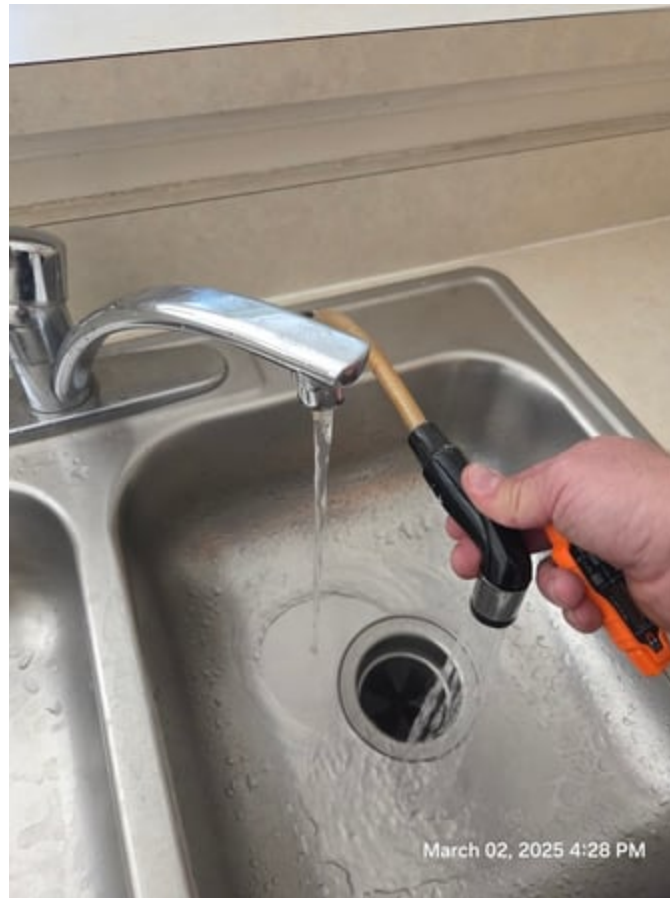
**Material Defect**

Kitchen sink did not transition between faucet and pull-down sprayer.

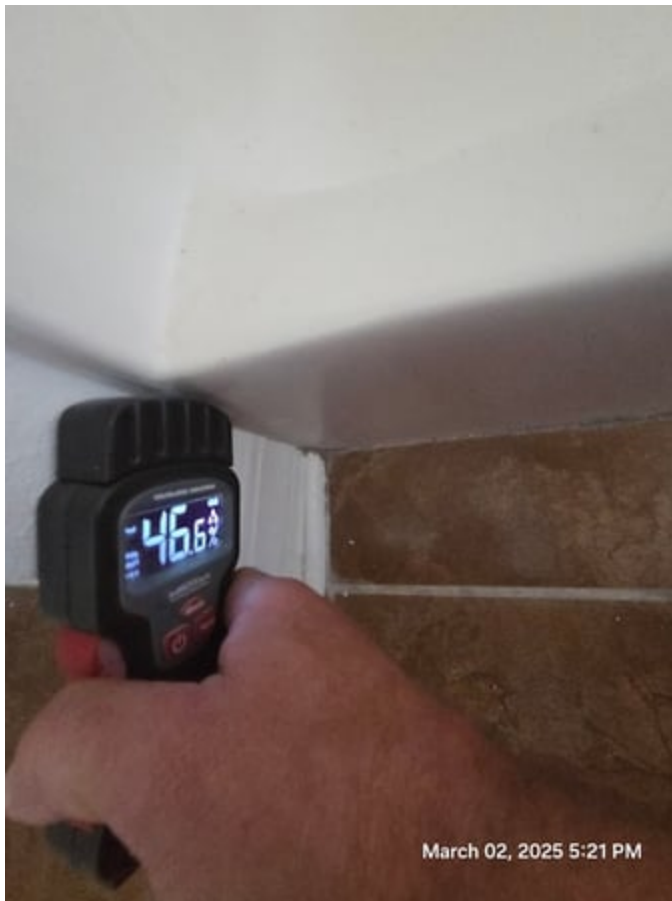
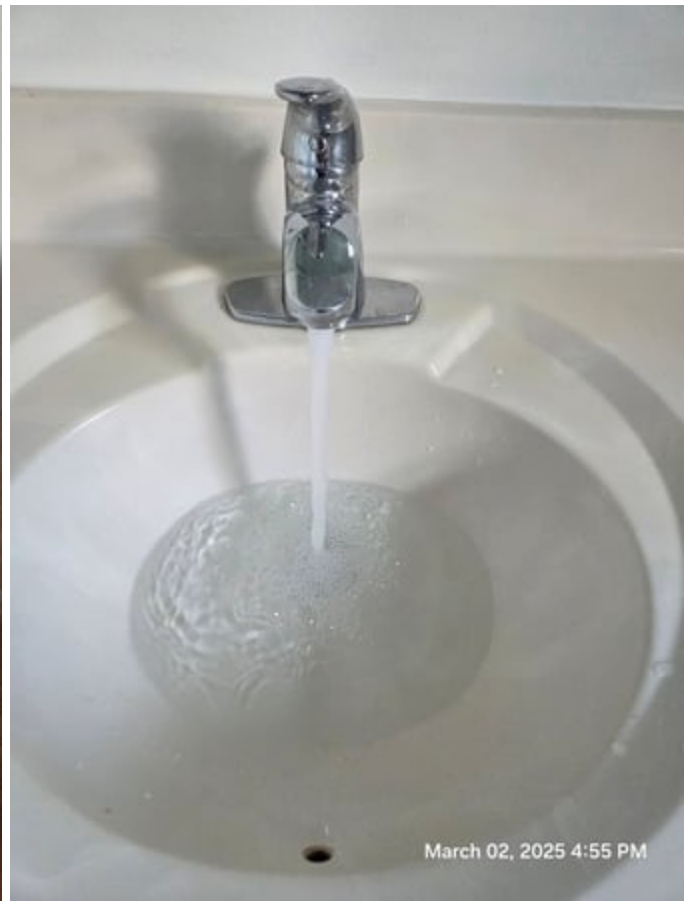
**Material Defect**

High levels of moisture intrusion were found around shower and tub enclosures. Recommend further evaluation by a certified contractor.

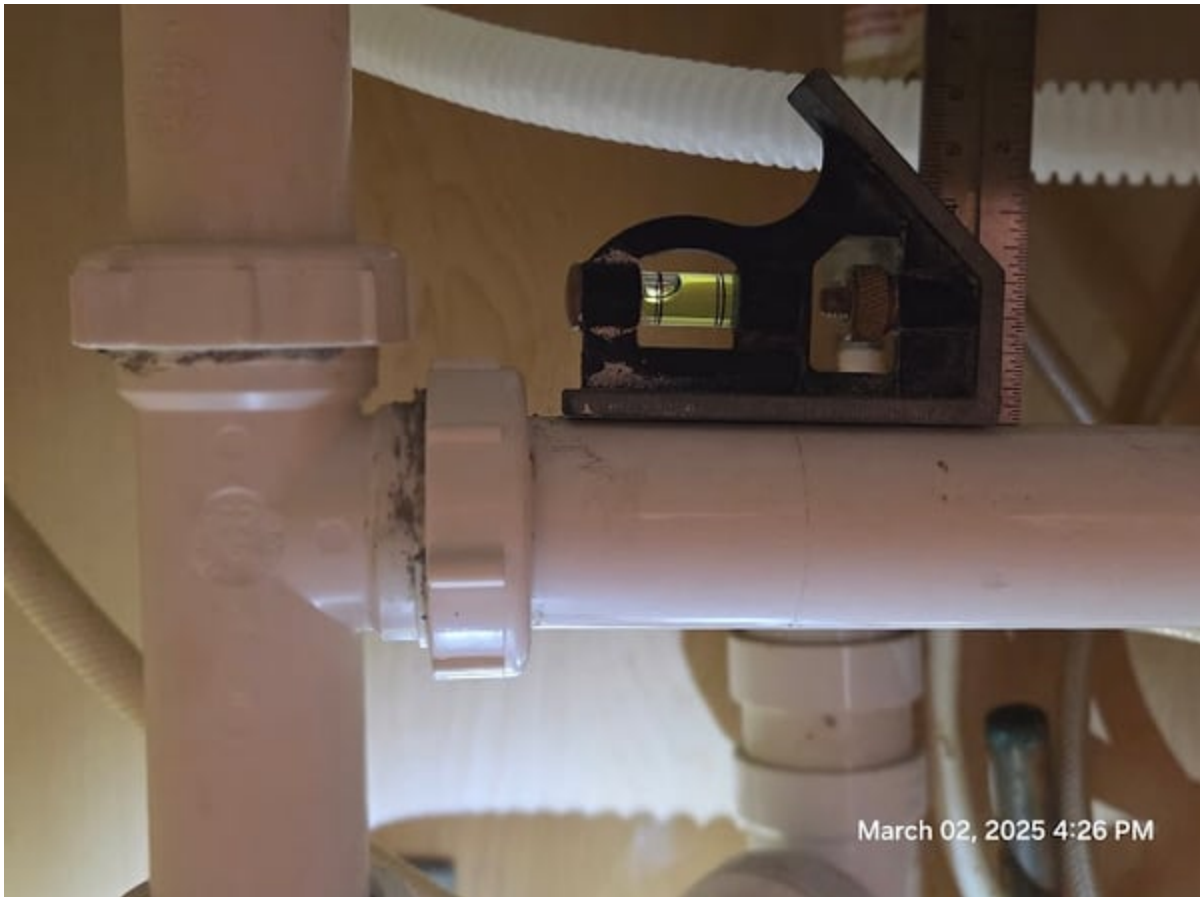
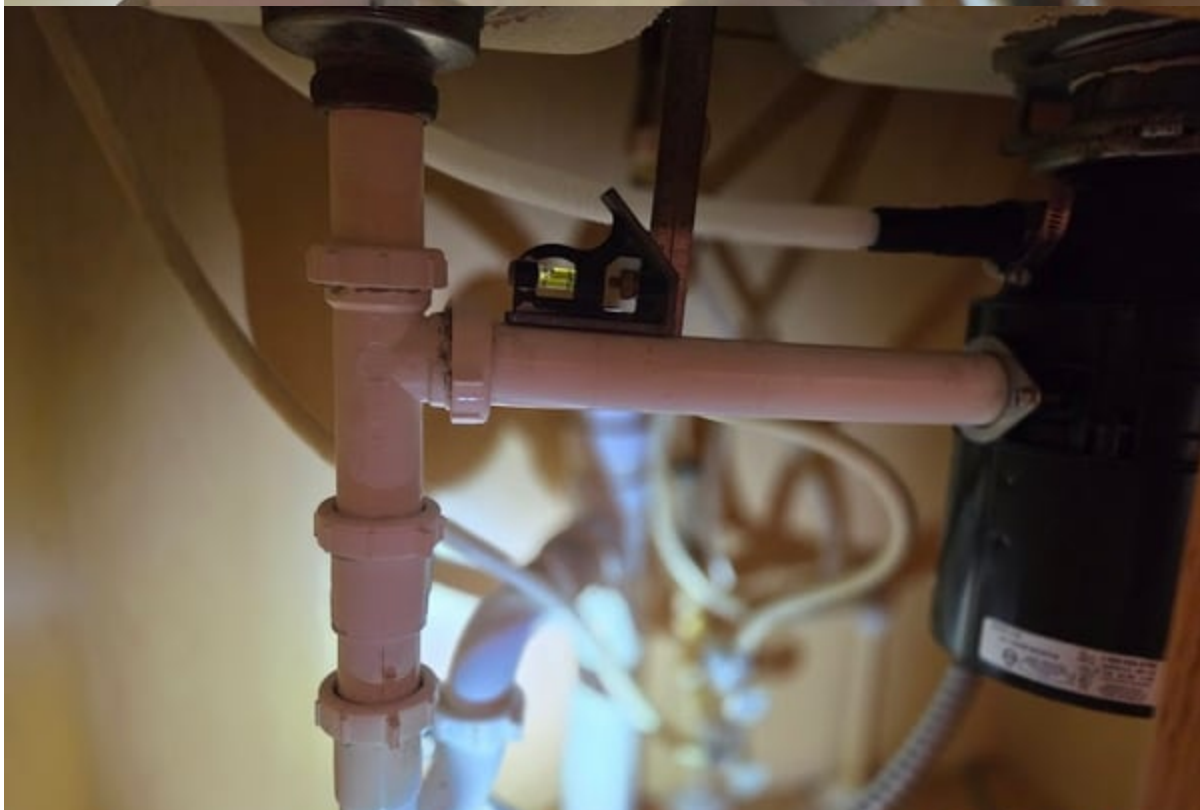
**Material Defect**

Plumbing in kitchen sink sloped away from the drain line. Recommend contacting a certified plumber. Tripple stacking of drainpipe adapters can cause various points of leakage and are a non-standard of practice.

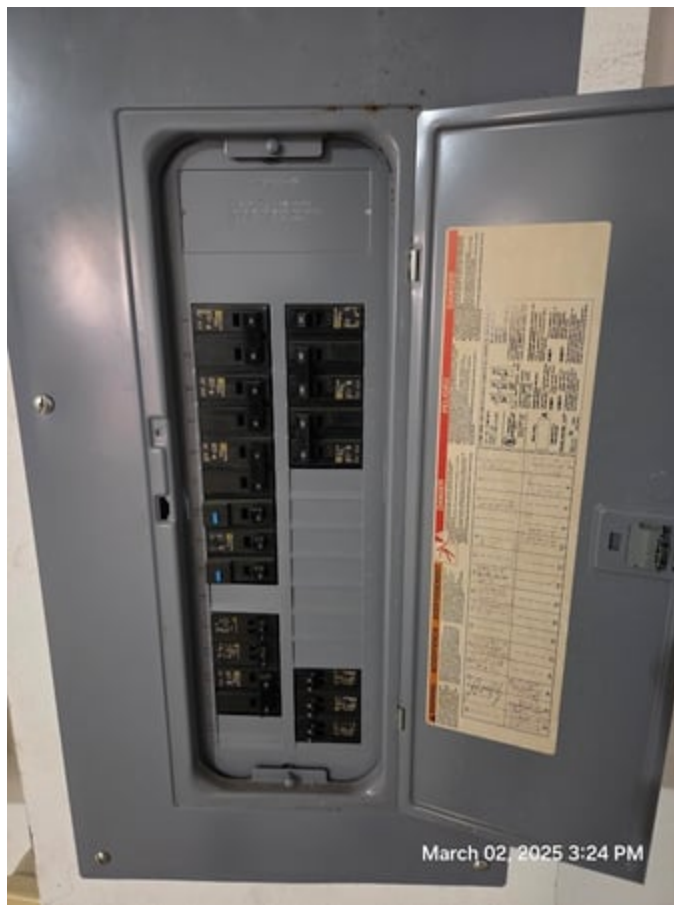
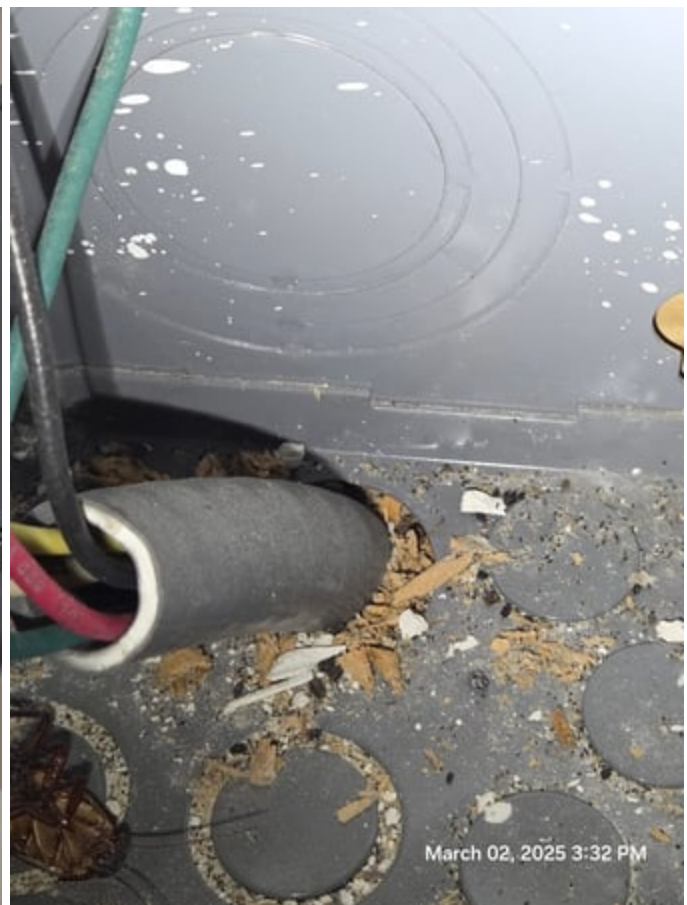
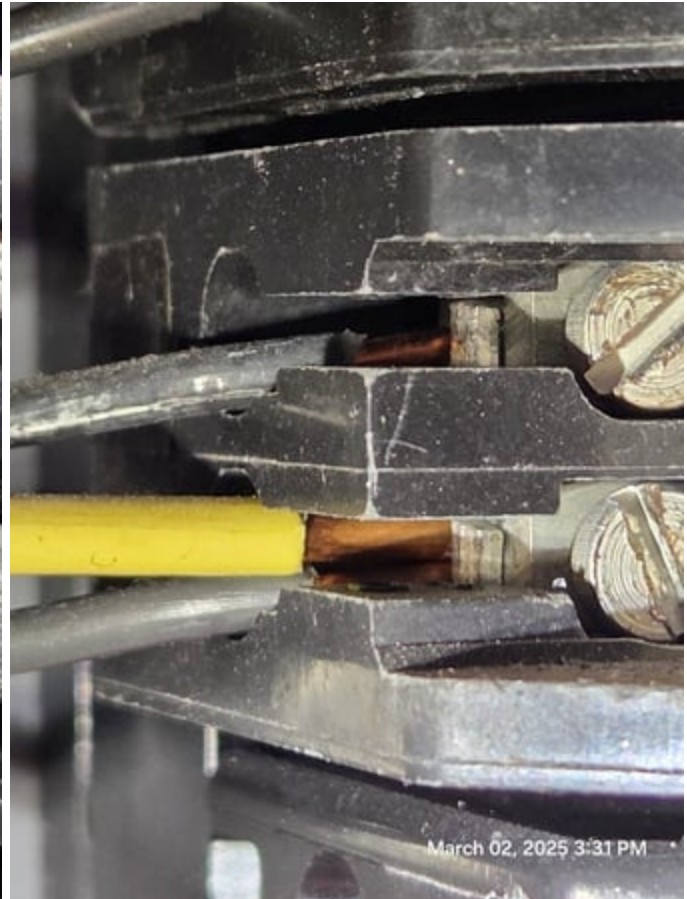
**Material Defect**

Knock out plug missing. Improperly attached neutral wire. Double stacking of conductors is not permitted on circuit breaker. Recommending contacting a certified electrician.

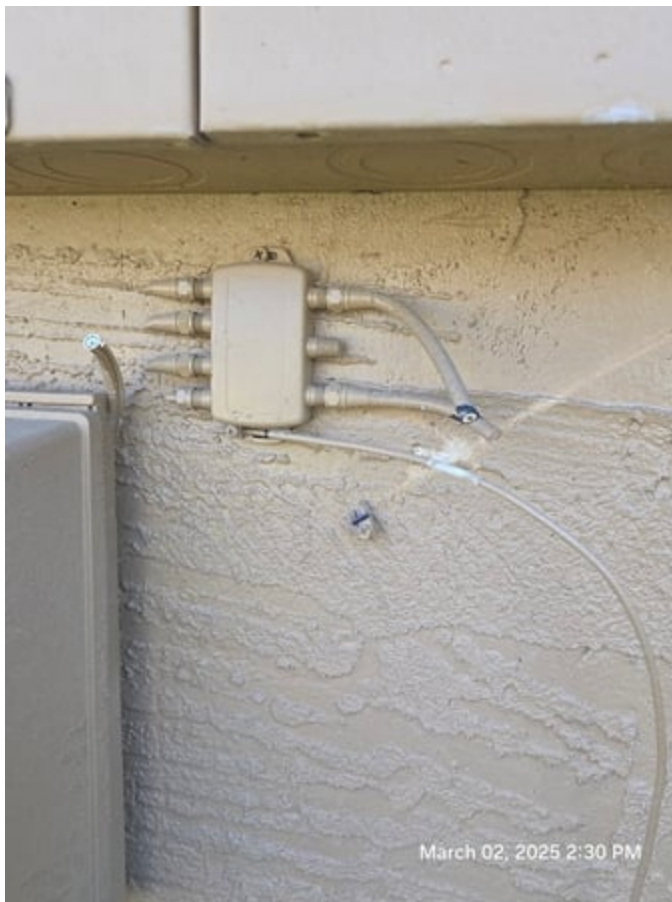
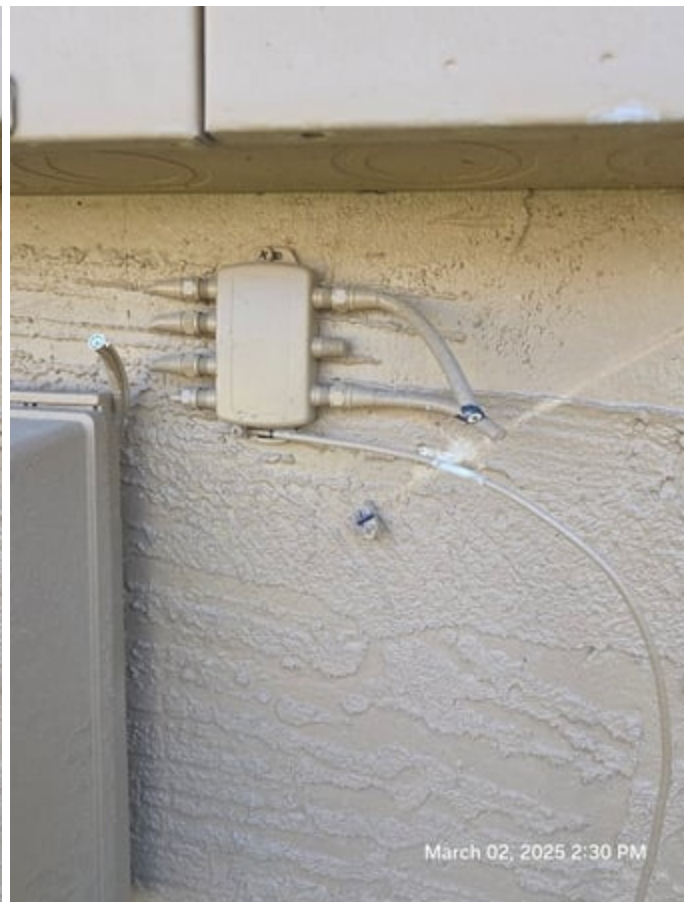
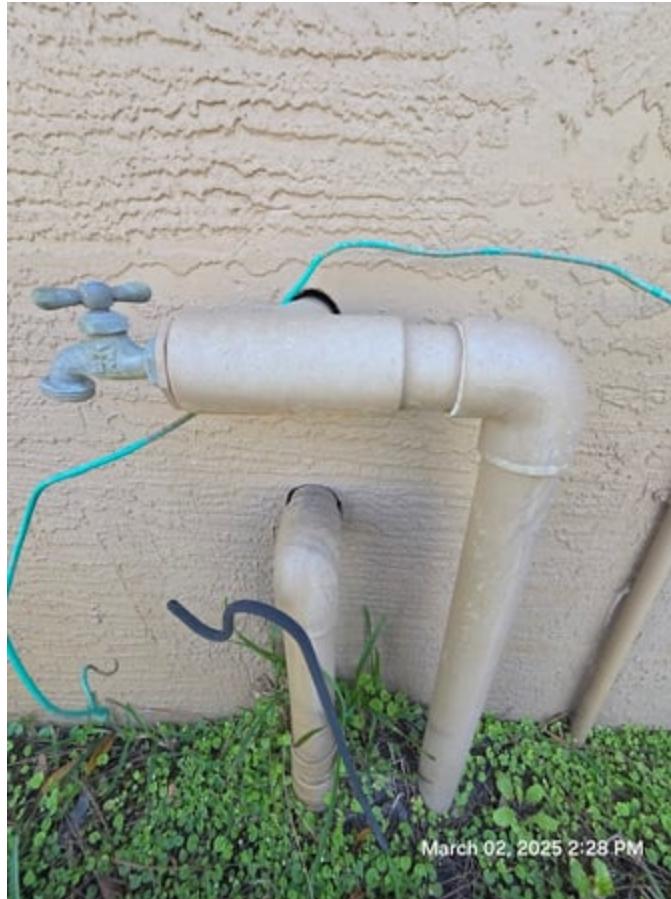
**Minor Defect**

Service provider cabling is not normally part of a home inspector's responsibilities but as a courtesy I wanted to note that the Co axial cabling has been cut off at the service entrance Loose bonding wire. Needs to be reconnected by service provider. Proper grounding of utilities is a standard of practice.

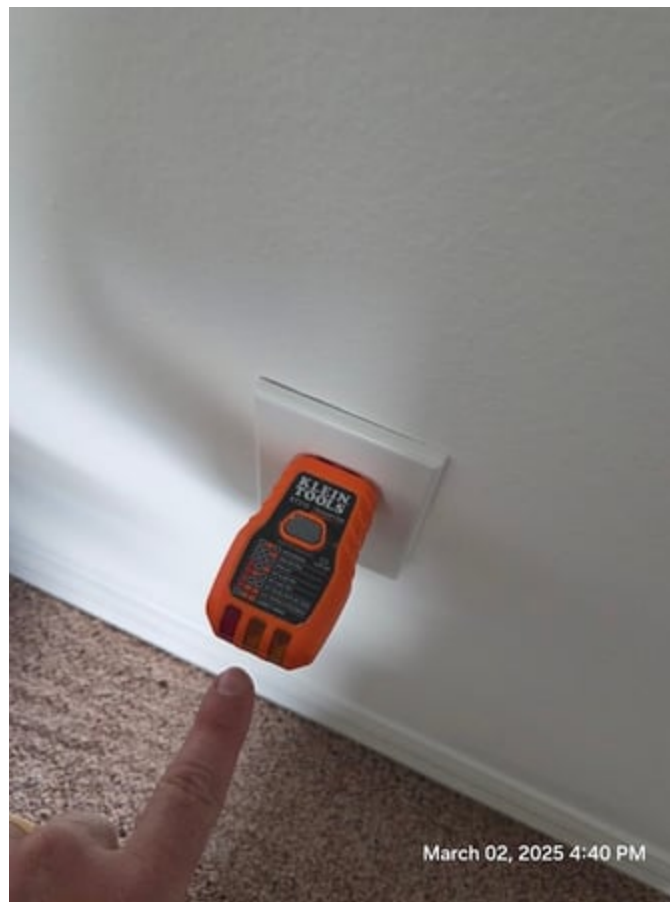
**Material Defect**

Bedrooms were not gfci protected. Current standards require all bedrooms to be on gfci circuits. Recommend further evaluation by a certified electrician.

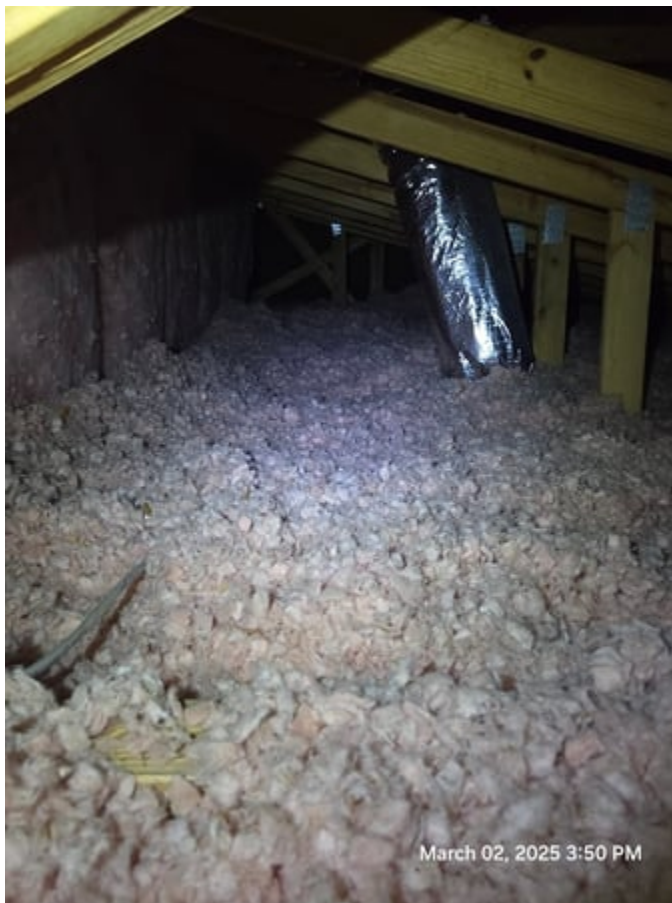
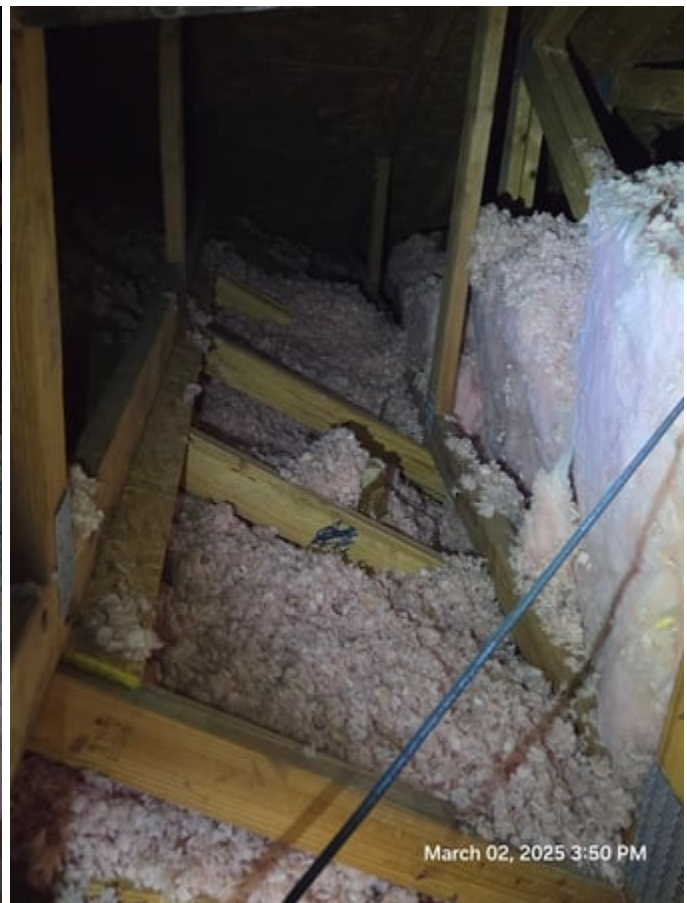
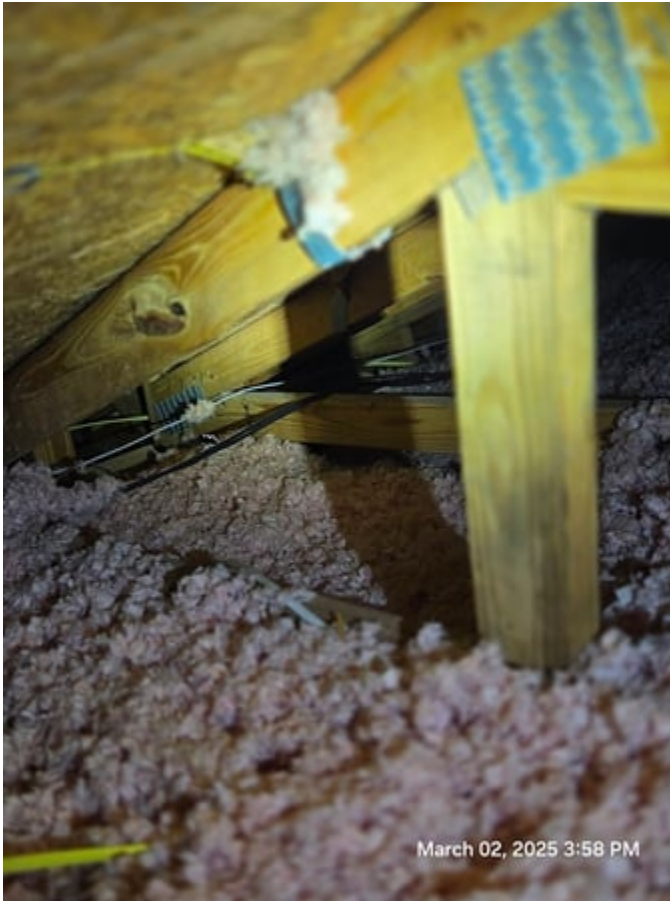
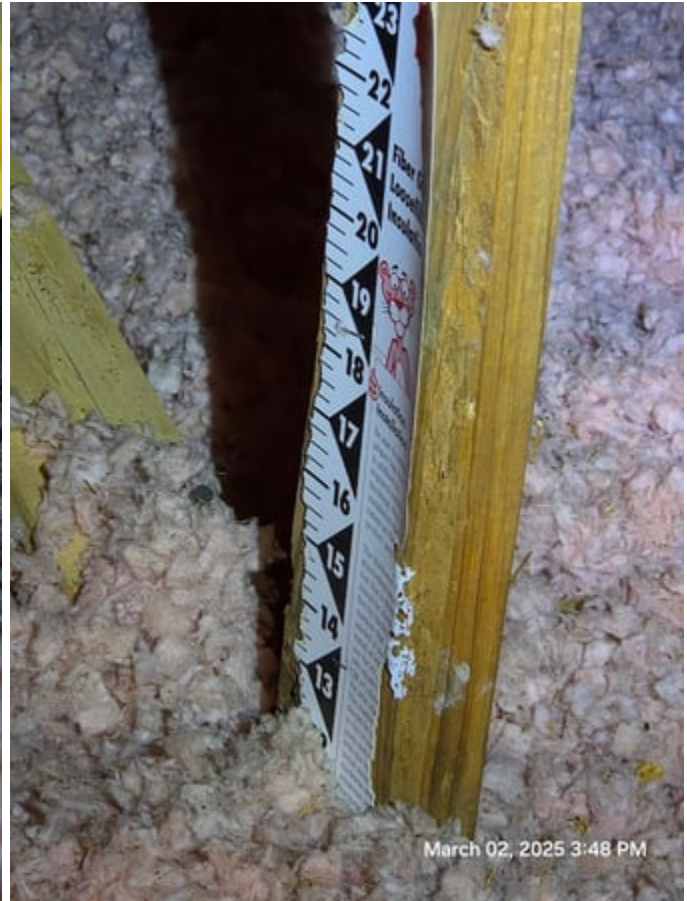
**Material Defect**

Uneven levels of blown insulation observed. This can lead to hot or cold spots inside the home.

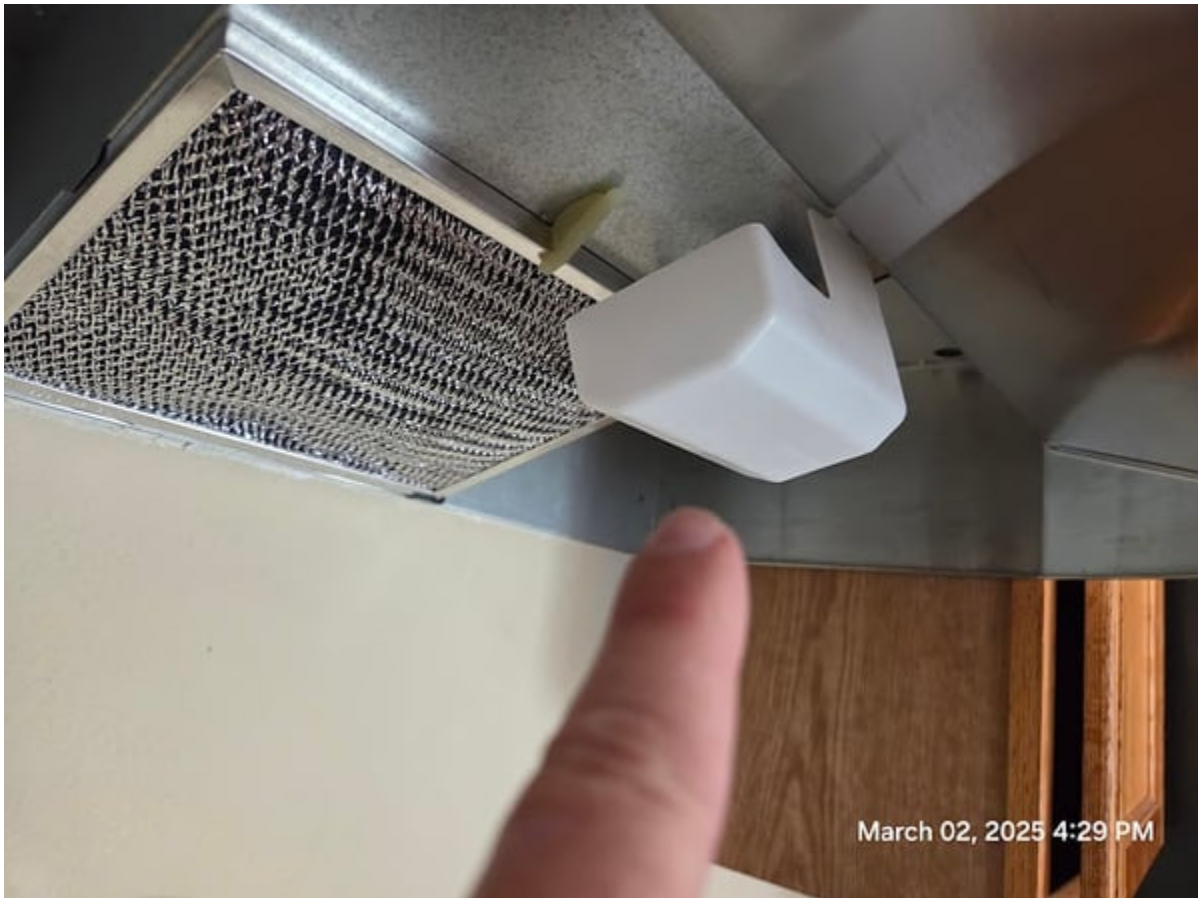
Material Defect

Inoperable light fixture above cooktop

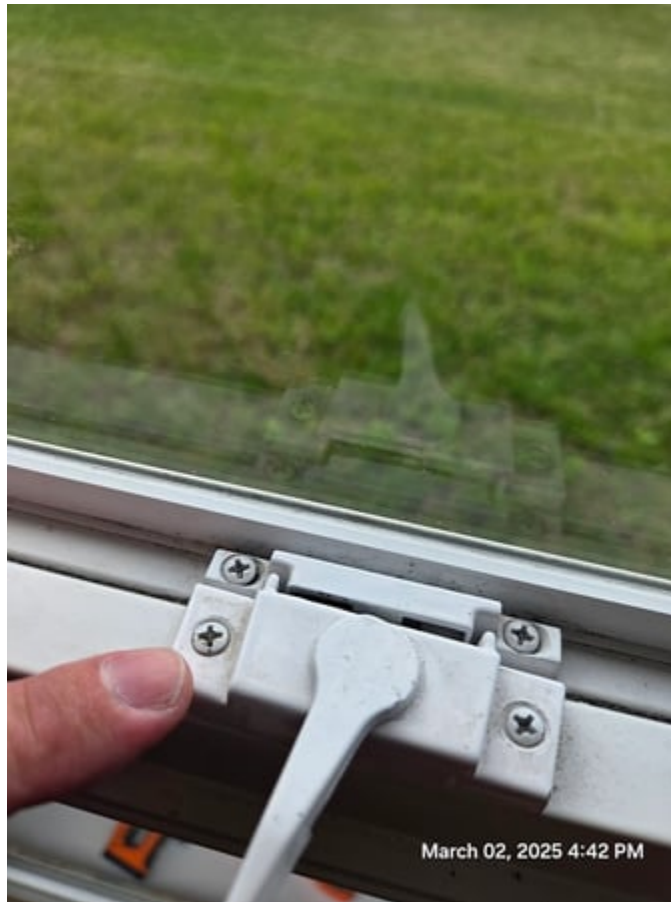
**Material Defect**

many latches were loose and not functioning properly

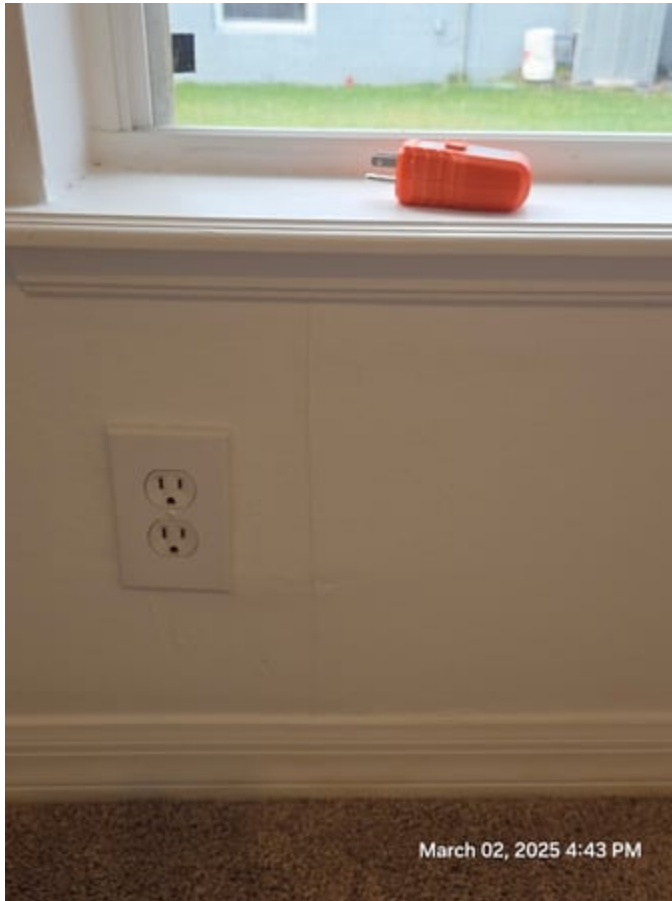
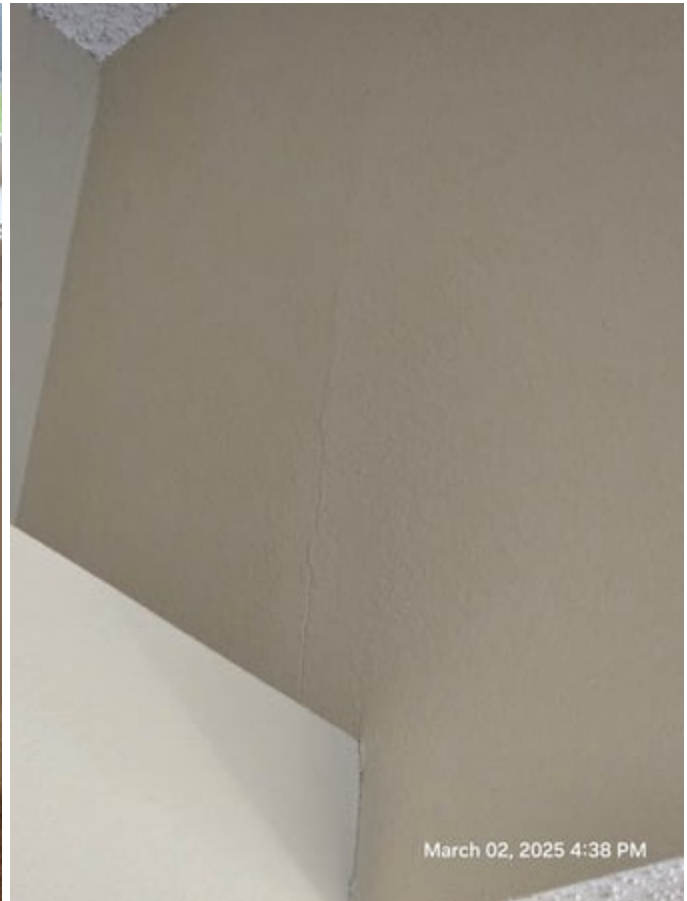
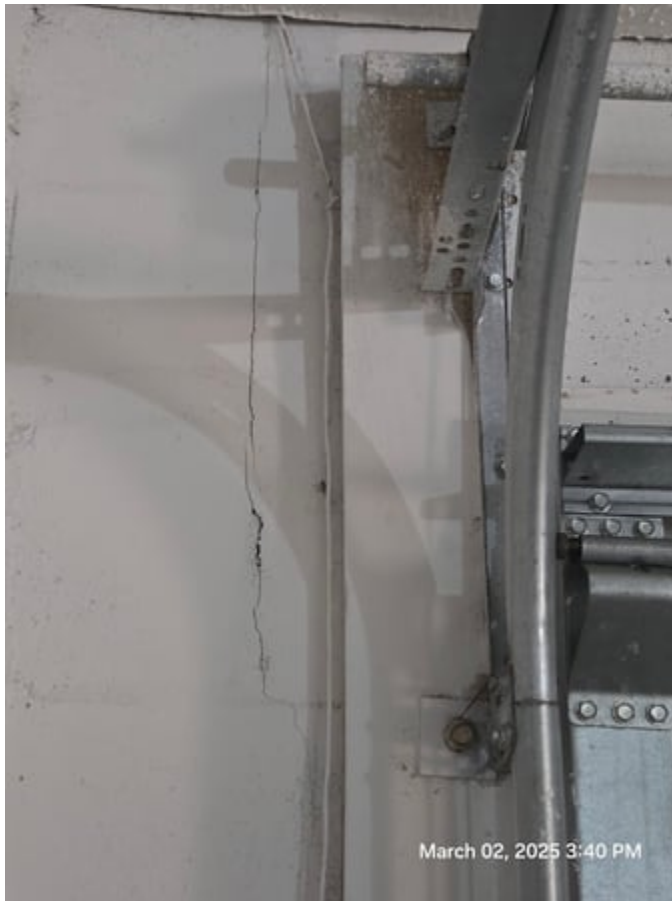
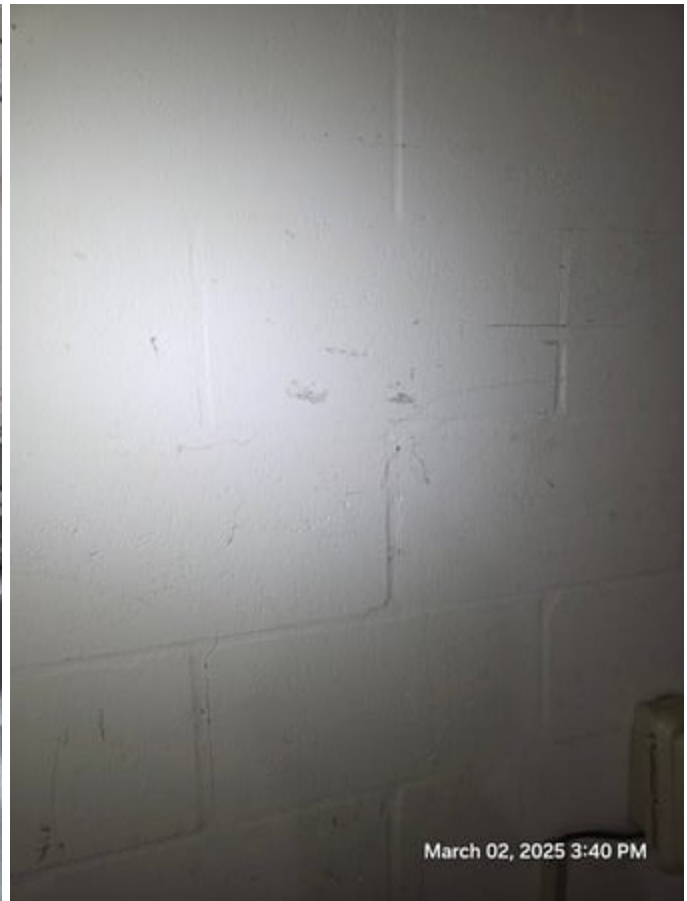
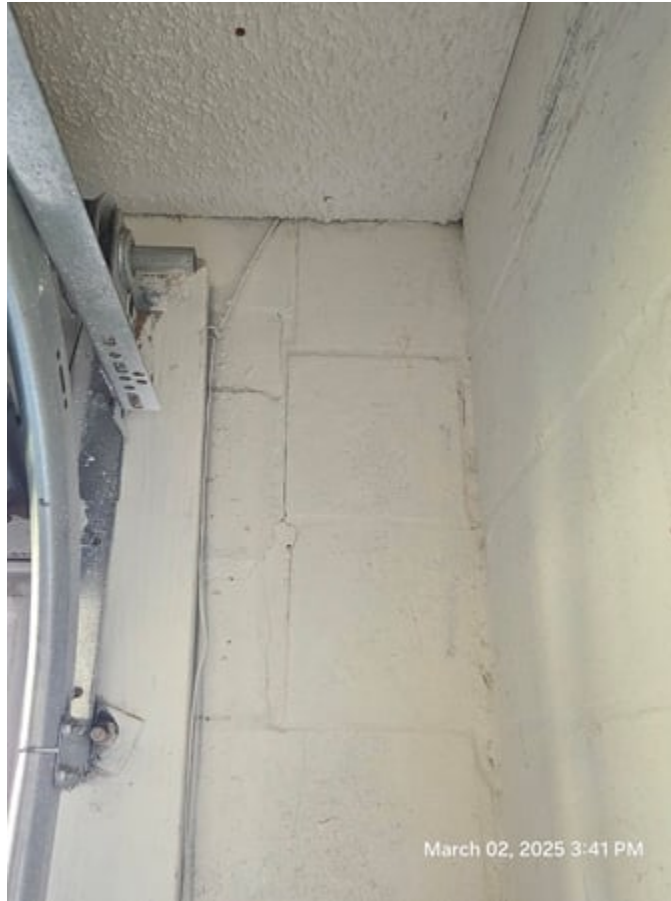
Minor Defect

settlement cracking observed. Most instance of settlement cracking is normal. Recommend monitoring .
