Inspection Report

2 Berryman Ave.
Los Angeles, California 90230

Frank Vogel
Vogel Inspections
(818) 642-8726
frank@vogelinspections.com
2275 E. Mariposa Ave.
El Segundo, CA 90245

Saturday
January 1, 2022

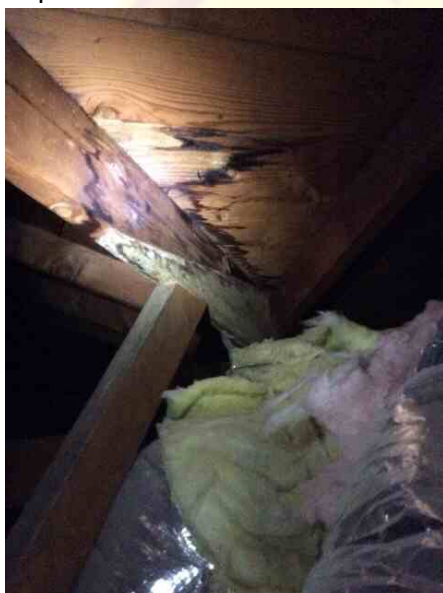
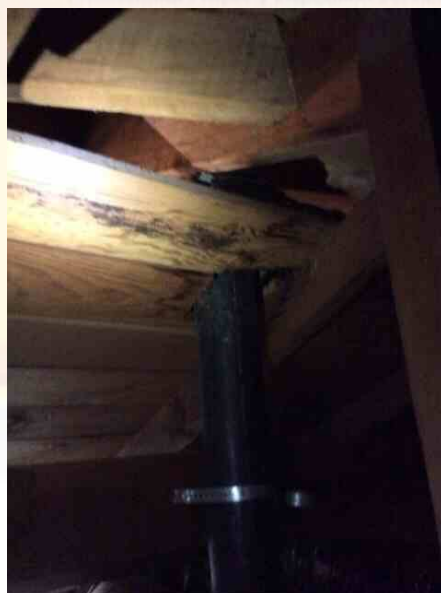
23: There is evidence of past leakage. Measures have been taken on the roof in the past to stop water intrusion. We cannot determine if active leaks still exist. We recommend monitoring this condition and/or inquiries of the owner.

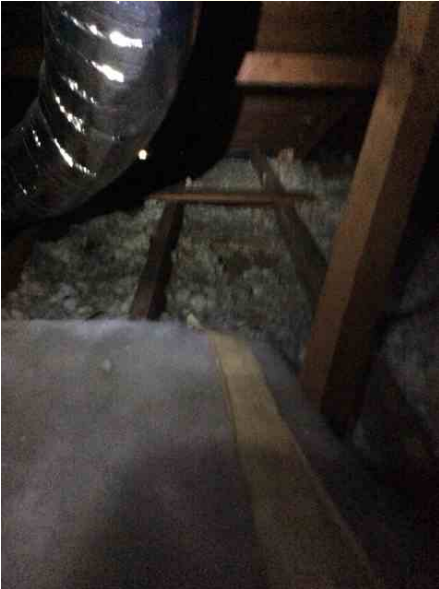
27: The insulation is sparse and/or incomplete at many areas. Installation of additional insulation in accordance to current standards is recommended for improved energy conservation.

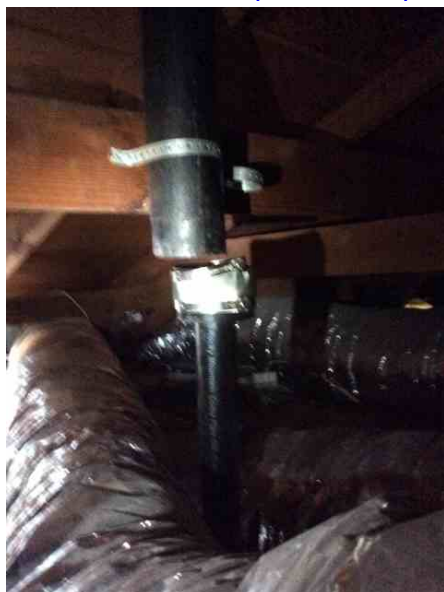
28: The vent piping near the hatch has been installed in a substandard manner and is disconnected. We recommend it be repaired or replaced at this time.

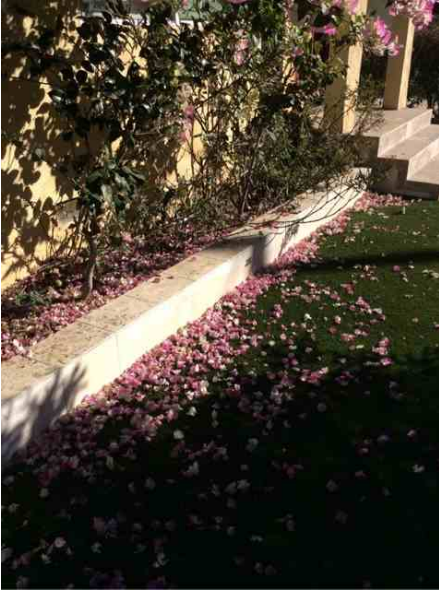
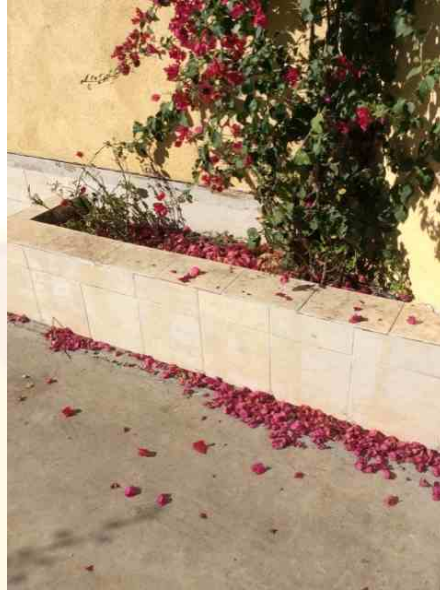
43: Drain provisions that are now standard are not installed at the planters. The current configuration of the planters near the exterior walls allows for water accumulation and intrusion into the basement and/or crawlspace. Repair is recommended.

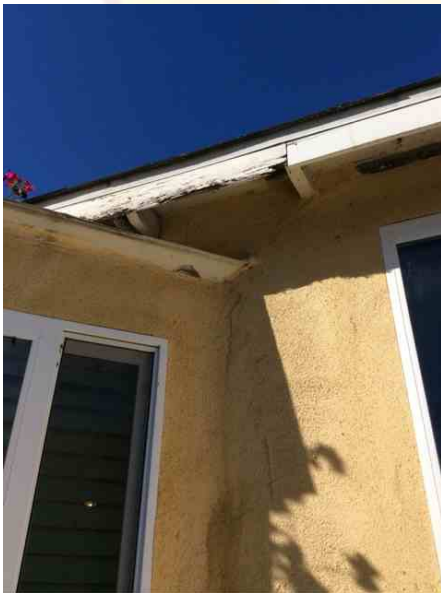
48: Sections of the fascia are deteriorated. We recommend they be repaired or replaced. A termite inspector should be consulted for a further examination, recommendations and repair.

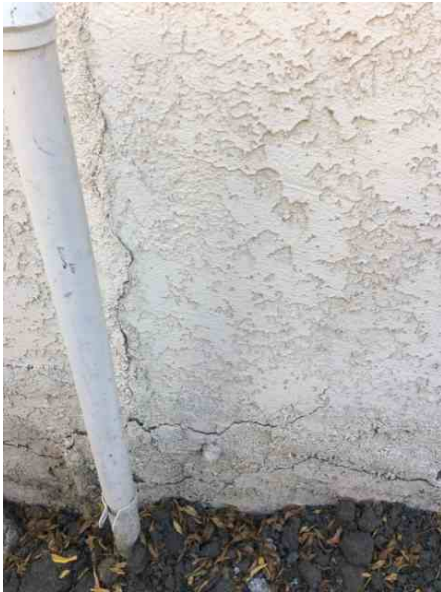
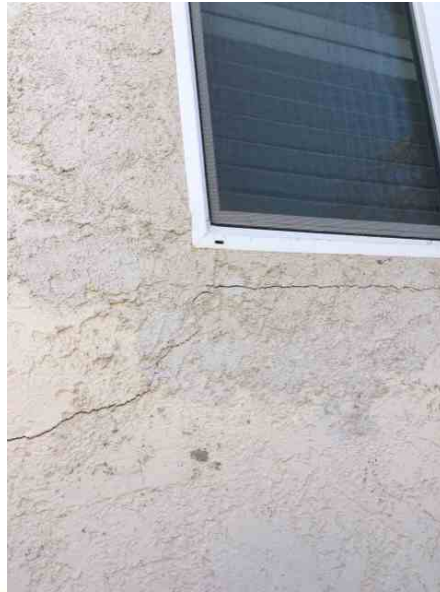
50: There is cracked stucco at many locations indicating movement. These surfaces can be patched, but if movement in the structure is not addressed, the cracks may return and/or become more noticeable.

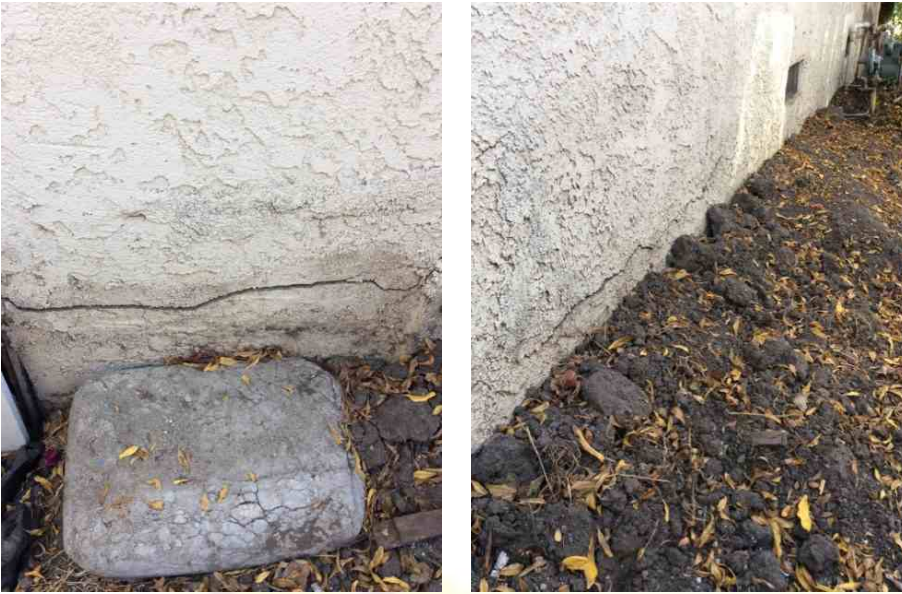
54: Sections of the stucco are cracked and damaged. The damage is likely the result of "seismic bulging". We recommend they be repaired or replaced.

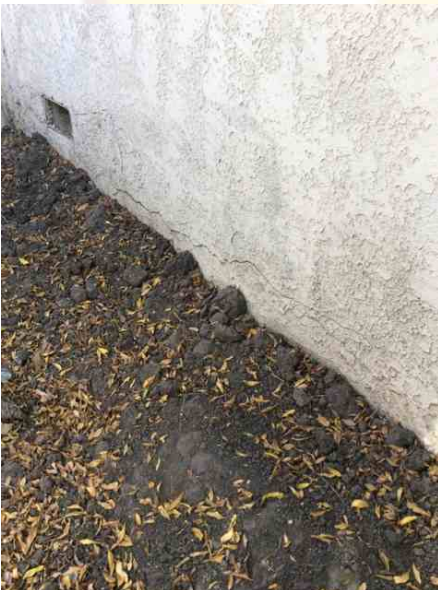
56: Obvious repairs and/or modifications have been made to the stucco walls. The repairs at the walls are likely the result of "seismic bulging". The owner may have information about the original conditions, the repair or remodeling work, and any permits that were required, obtained and completed.

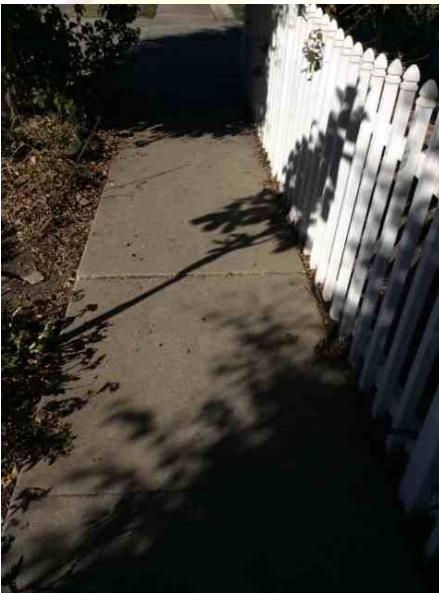
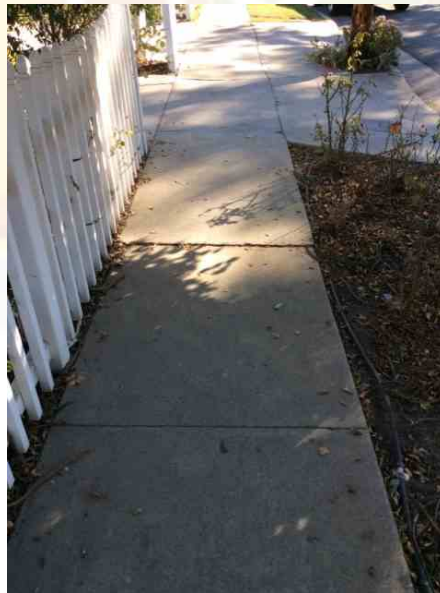
65: There are trip hazard developing in the public sidewalk. We recommend it be patched or repaired to prevent injury.

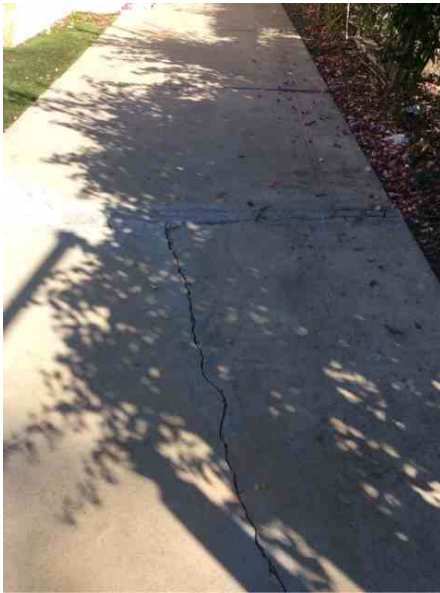
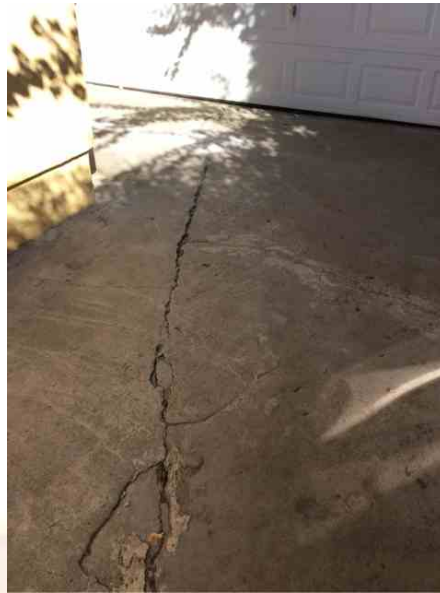
66: There are significant cracks and settlement in the driveway. These may indicate poor soil conditions and/or poor preparation of the substrate. The cracks could be sealed to prevent water intrusion, but replacement of the drive would be a more permanent solution.

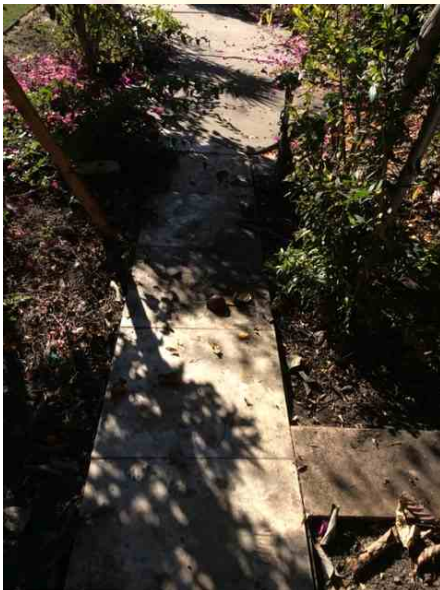
68: The polished tile at east walkway is substandard and slippery when wet which presents a slip hazard. Cracked and damaged tiles are noted at the walkway.

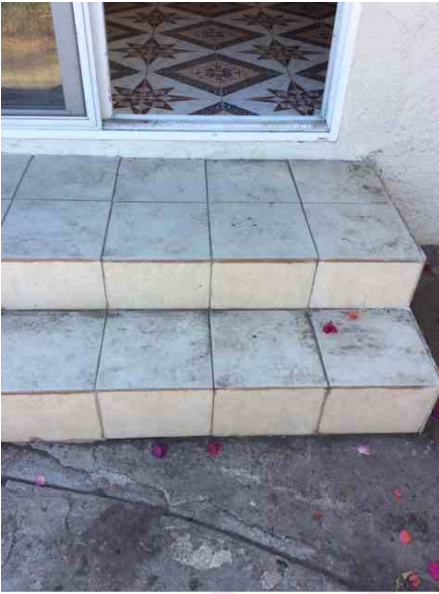
70: The polished tile installed at the rear porches and steps is substandard as it is slippery when wet which presents a hazard. Replacement or other alteration at this time should be considered.

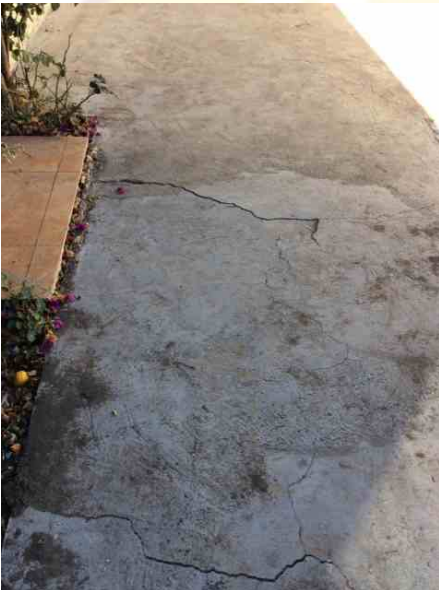
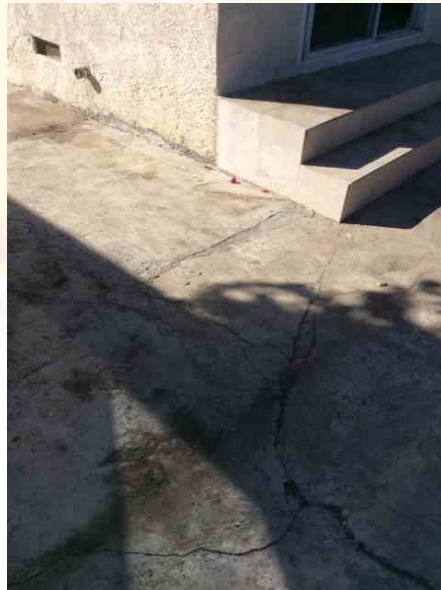
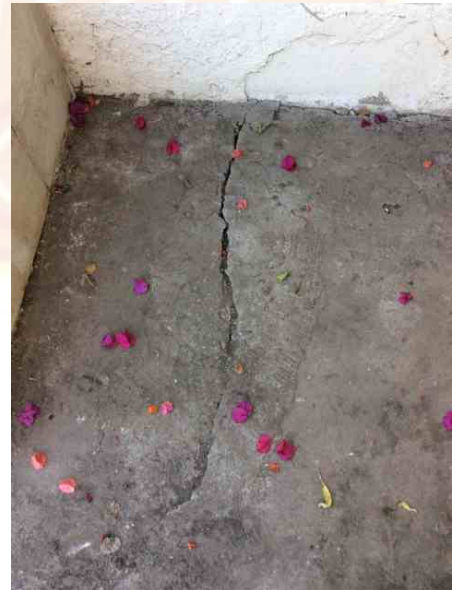
71: The concrete patio has cracked and settled. Evidence of water pooling is also observed at the surface. Repair or replacement for a better appearance is optional.

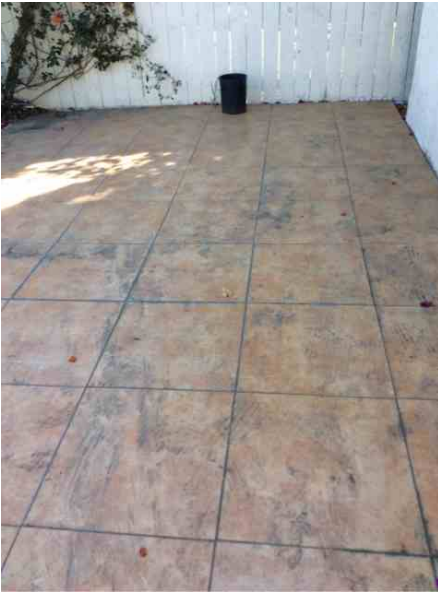
72: The polished tile installed at the southeast patio is substandard as it is slippery when wet which presents a hazard. Replacement or other alteration at this time should be considered.

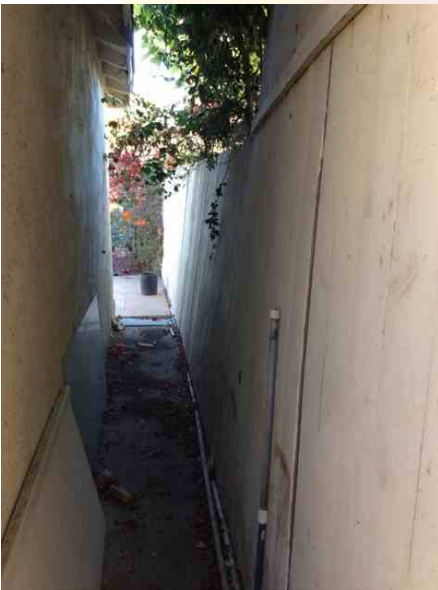
74: Retaining walls, yard walls, fences and gates are not within the scope of the inspection. However some comments are given as a courtesy and for a better understanding of the property. Sections of the wood fences and/or gates are degraded and damaged. Further review of the walls, fences and gates by a qualified expert should be considered.

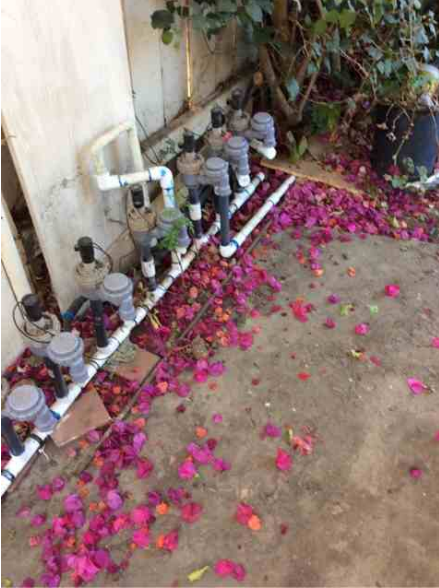
76: Testing of the irrigation system is beyond the scope of this inspection. Although he did note that the loose and exposed piping is substandard. Care should be taken as to not excessively irrigate the grounds. Structural damage is often related to excessive irrigation. The sprinkler heads should be monitored and adjusted away from the building as needed. We recommend verifying at this time that the sprinkler timer(s) is programmed properly and in accordance to local ordinances.

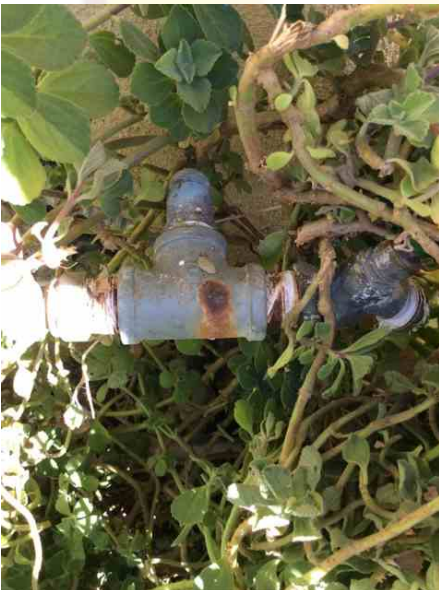
77: The copper water pipe connected directly to galvanized piping near the main shut off valve is non-conforming as the metals are not compatible. To prevent electrolysis and corrosion, we recommend proper separation and/or insulation be installed.

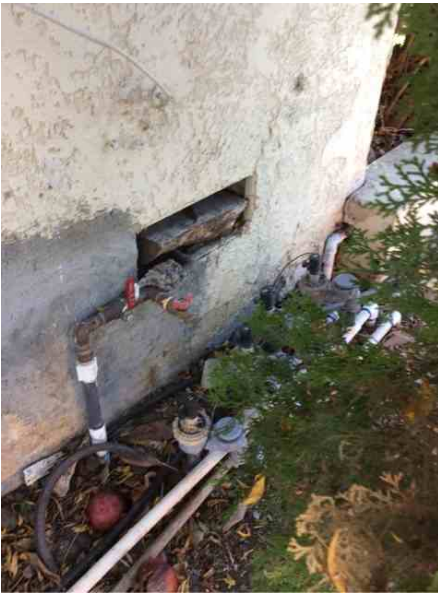
81: Several crawl space vent screens are damaged or incomplete. We recommend they be repaired or replaced to prevent access by rodents or other pests.

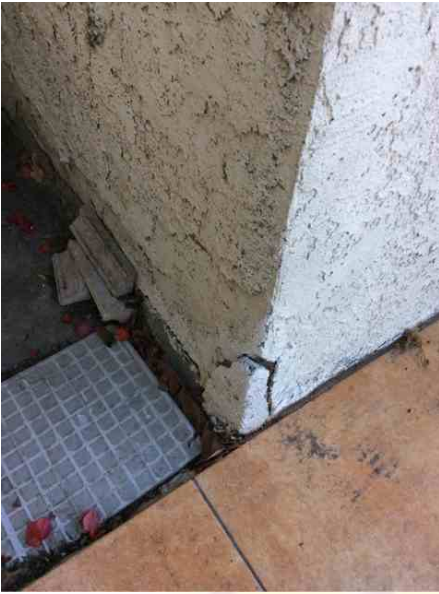
86: Cracks and surface deterioration is noted at the stucco. Attention as maintenance is recommended.

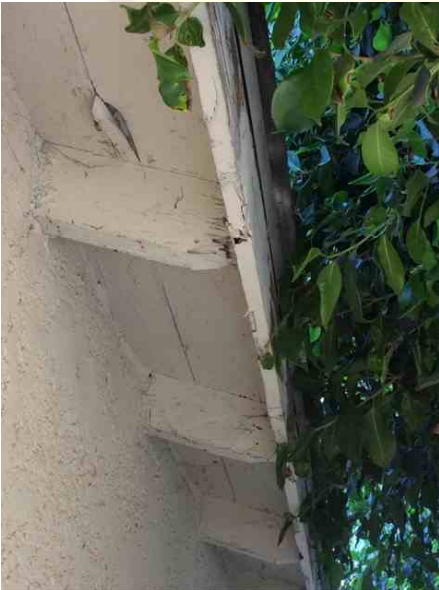
87: Sections of the framing and facias below the roof structure are degraded. The need for repair and rehabilitation should be anticipated. A termite inspector should be consulted for a further examination, recommendations and repair.

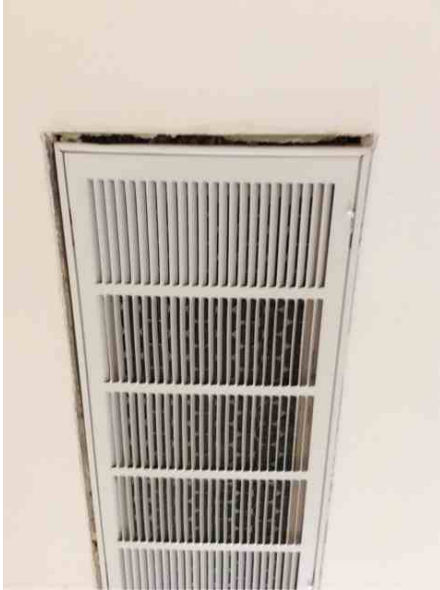
89: The ceiling and return air opening is configured in a substandard manner.

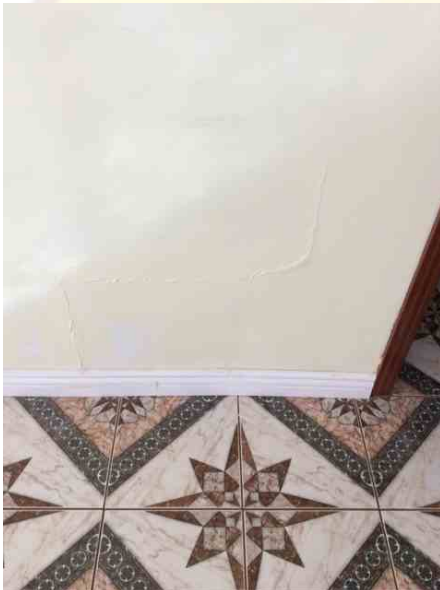
91: There are minor wall cracks. These can be patched, prepared and finished in the course of routine maintenance. It should be understood that this type of cosmetic cracking may reoccur due to minor movement in the structure.

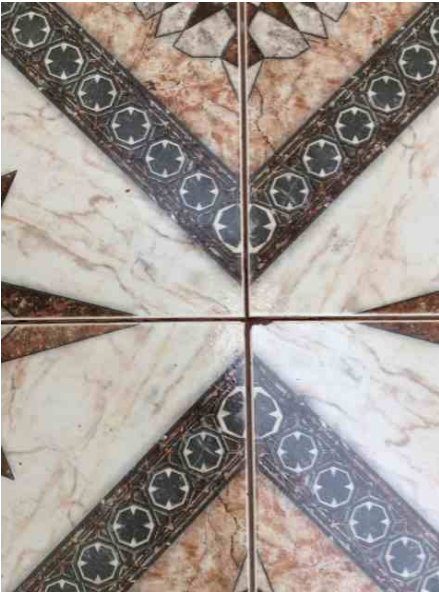
93: The tile floor is generally in satisfactory condition. Cracks and missing grout is noted between the tiles within the hallway area.

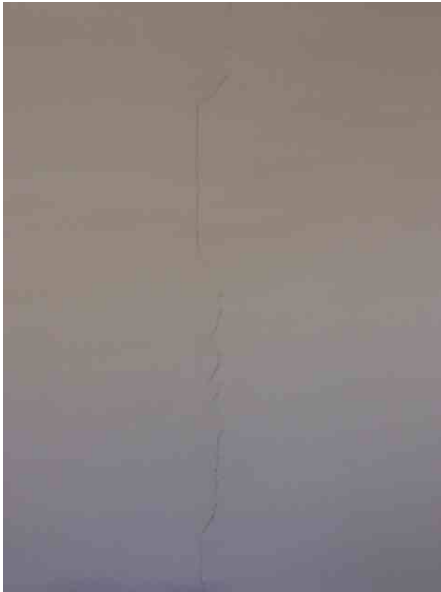
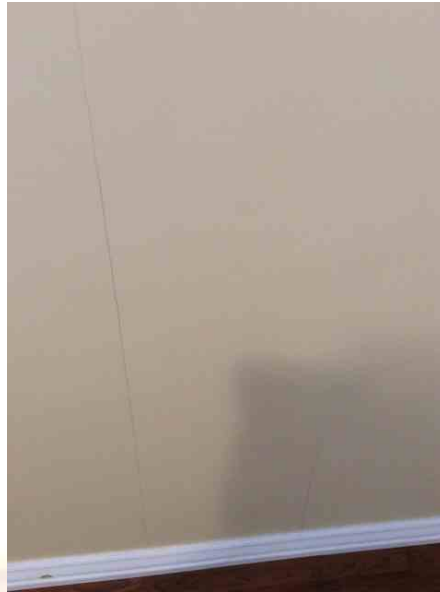
118: There are minor wall cracks. These can be patched, prepared and finished in the course of routine maintenance. It should be understood that this type of cosmetic cracking may recur due to minor movement in the structure.

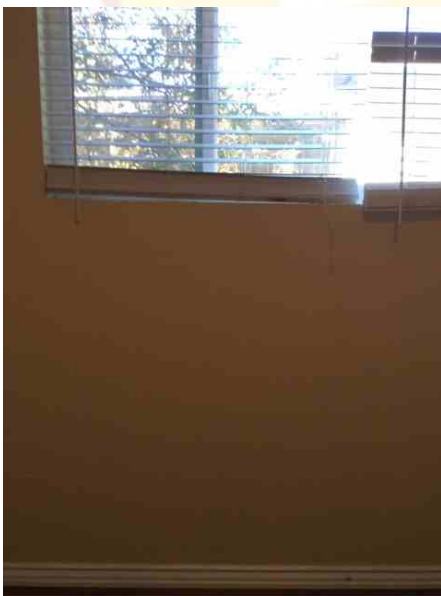
120: Windows are over forty four inches above the floor. An emergency egress meeting certain requirements is mandatory for all sleeping areas. The condition may be permissible under the "Grandfather Clause". Although we recommend installation of such an egress in accordance with present standards be considered.

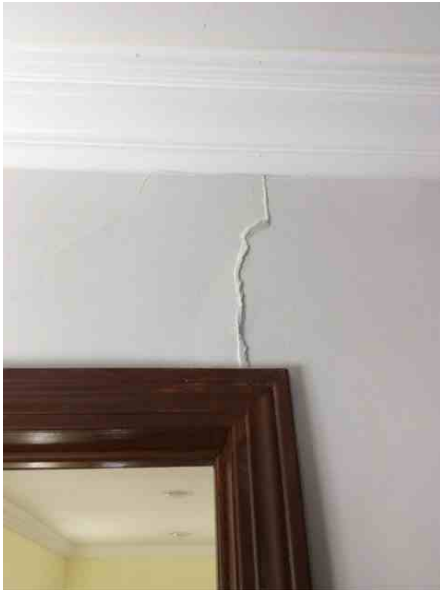
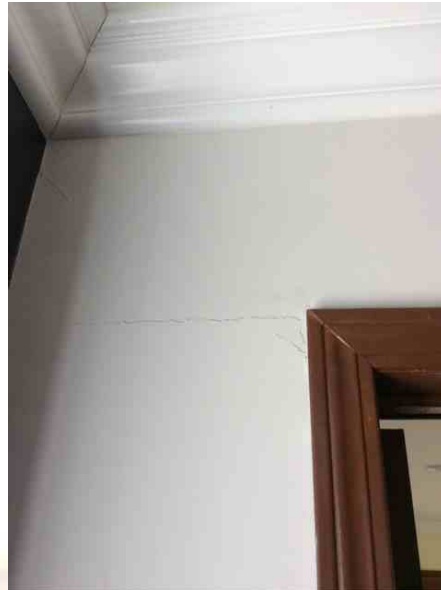
135: There are minor wall cracks. These can be patched, prepared and finished in the course of routine maintenance. It should be understood that this type of cosmetic cracking may recur due to minor movement in the structure.

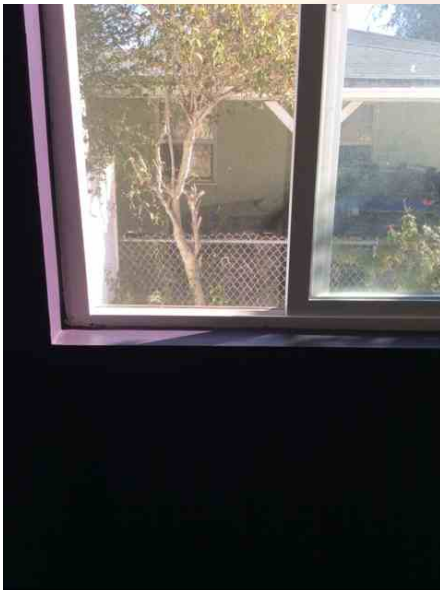
138: The added window opening is small and may not be useful in an emergency. Check for permits. An emergency egress meeting certain requirements is mandatory for all sleeping areas. We recommend installation of such an egress/ ingress in accordance with present standards.

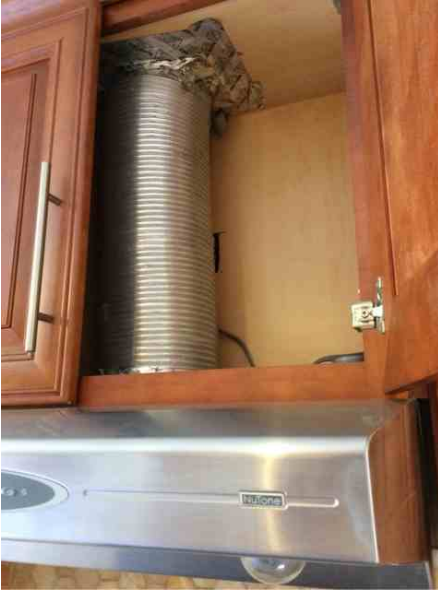
163: The corrugated aluminum 'flex duct' visible at the attic, is not permitted for kitchen exhaust fans as it can be a fire hazard. Replacement of this duct with an approved material in accordance to standards is recommended.

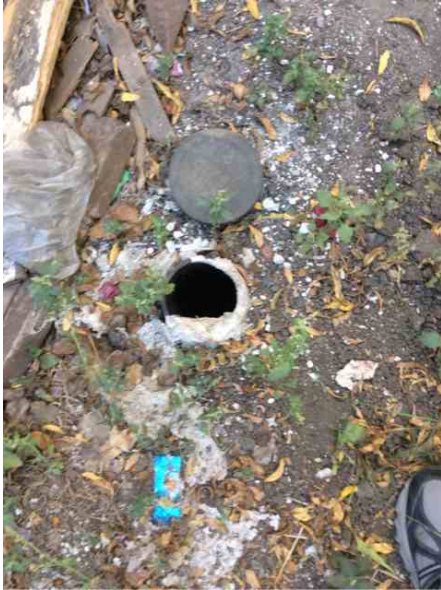
200: A clean out is noted at the north grounds. Evidence of sewage discharge is noted at the clean out and soil. Further examination and repaired by a plumber is recommended.

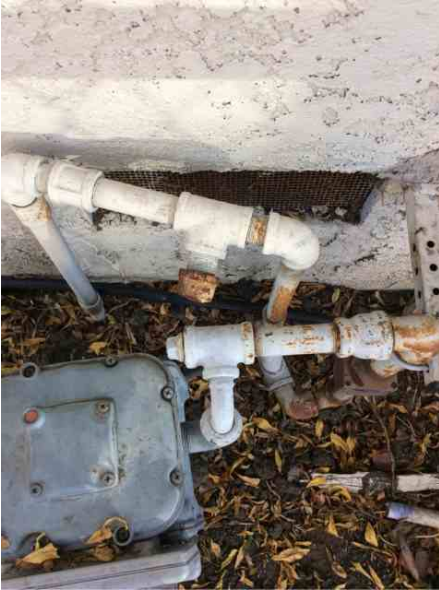
206: A shut off valve which is currently standard is not installed at the added piping adjacent the meter.

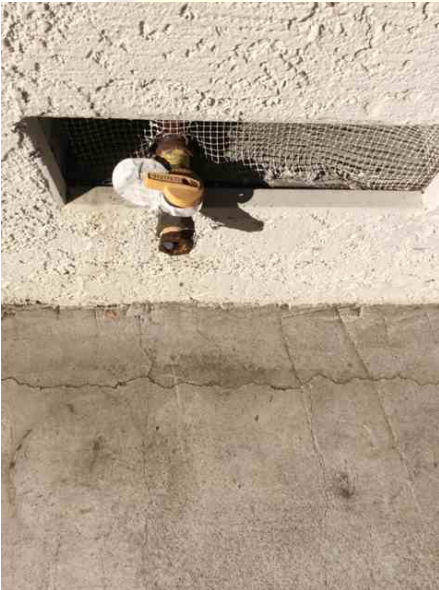
207: There is an uncapped gas valve at the south wall. If it remains unused, we recommend it be capped to reduce the chance of gas leakage.

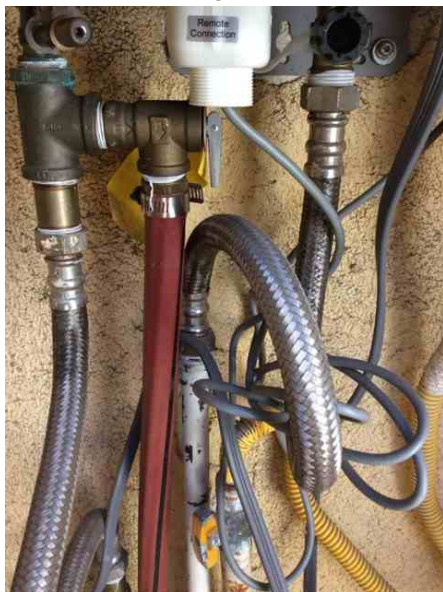
223: Use of the garden hoses nonconforming. Repair in accordance to standards is advised.

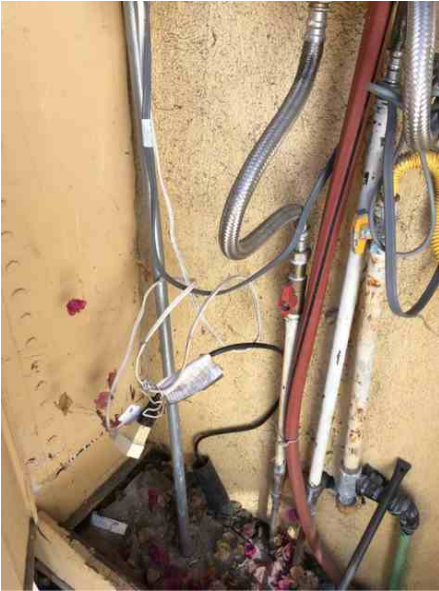
237: We found extension cord and/or improper wiring in use. This type of wiring is easy to overload and can be easily damaged. Removal of all substandard wiring and replacement with proper circuitry is recommended.

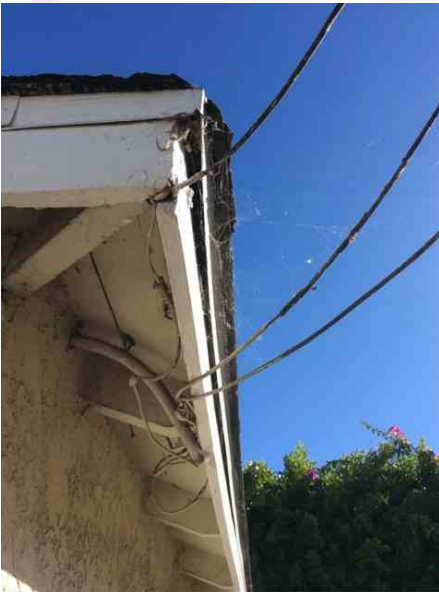
238: The exposed overhead conductors serving the garage is a common observation for homes of this age. However it does not comply with current standards. The condition is permissible under the "Grandfather Clause". The conductors insulation is weathered and the conductors are exposed. Replacement at this time in accordance to current safety standards is recommended.

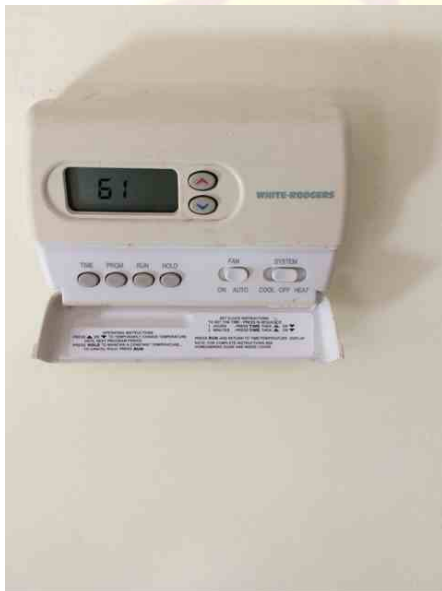
255: The thermostat does not respond to commands. We recommend it be replaced.
