## Mock Inspection Report

9 Reynolds Place, Palm Coast, FL, USA

Mar 2, 2025

Performed by **David MacCuish**

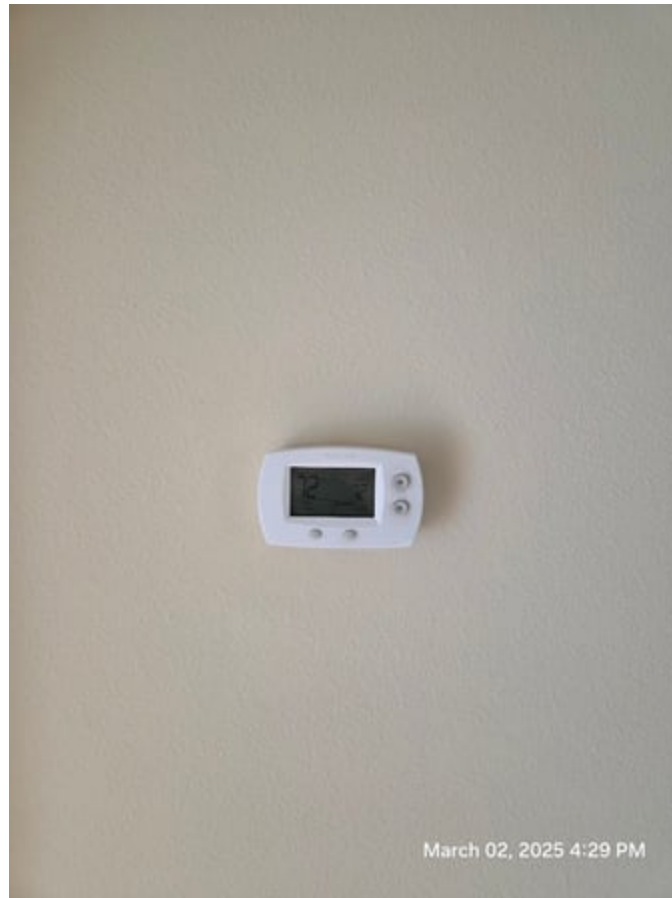
- Thermostat is located on wall at garage entrance.

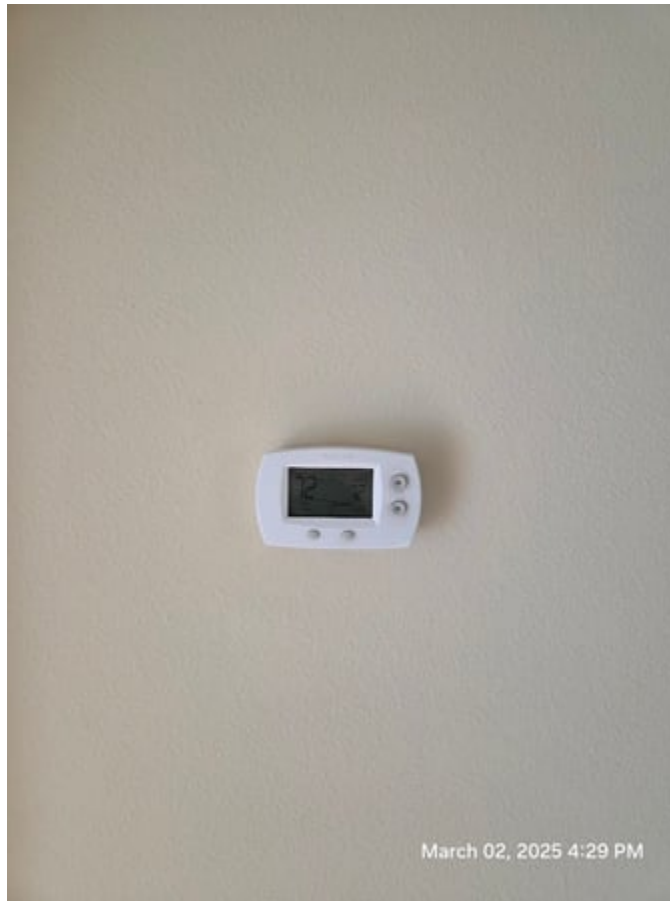
- On wall to entrance of garage.

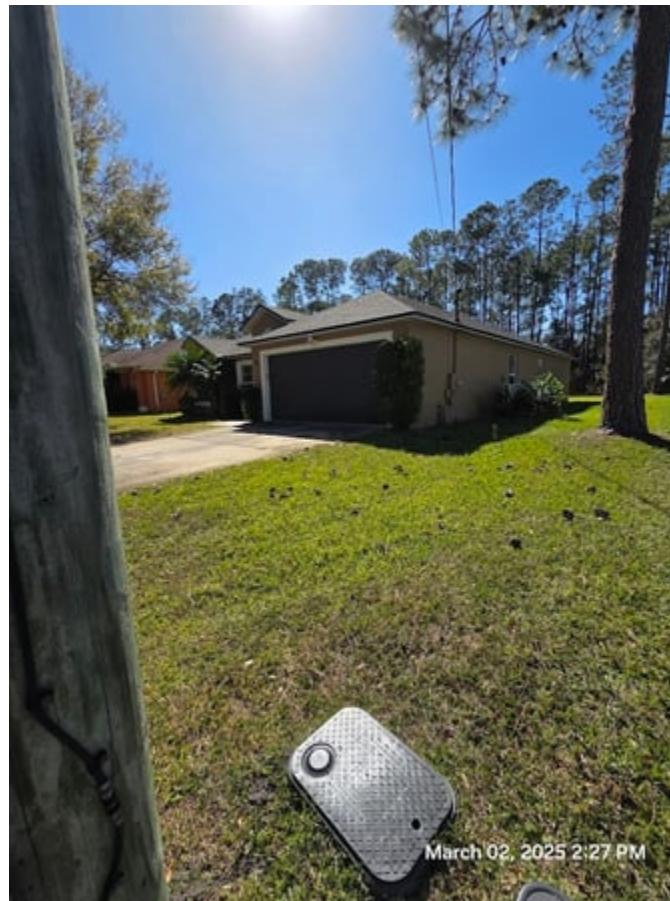
Main water supply by city. Meter located on corner.

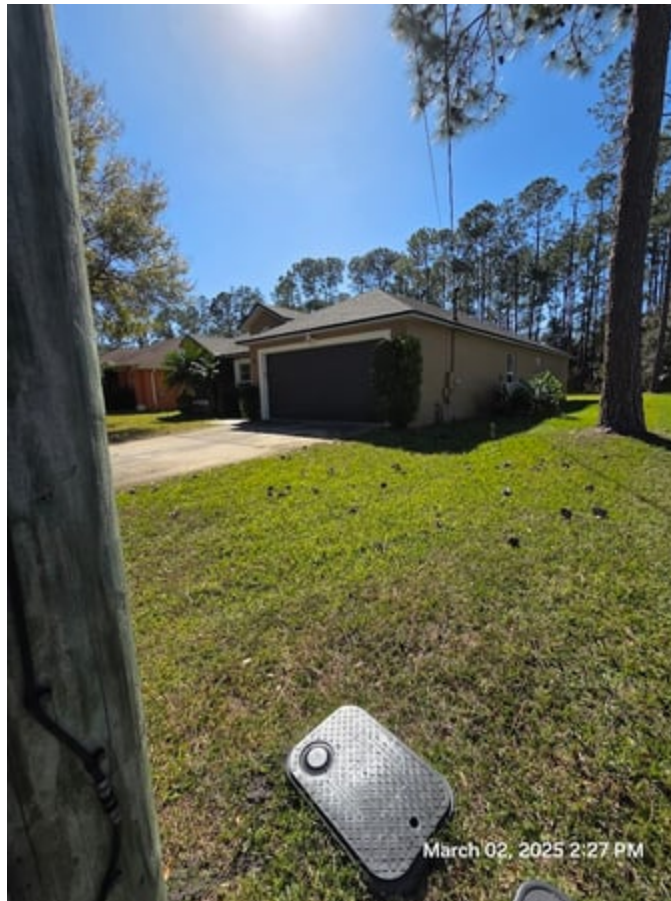
- Main water supply shut off valve located at corner of property

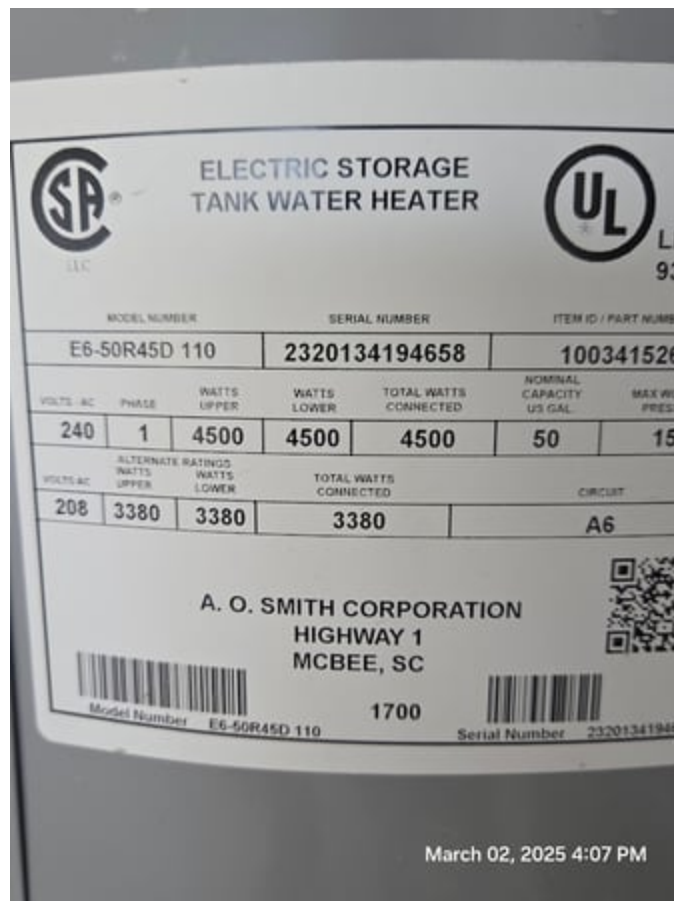
- 50 gallon

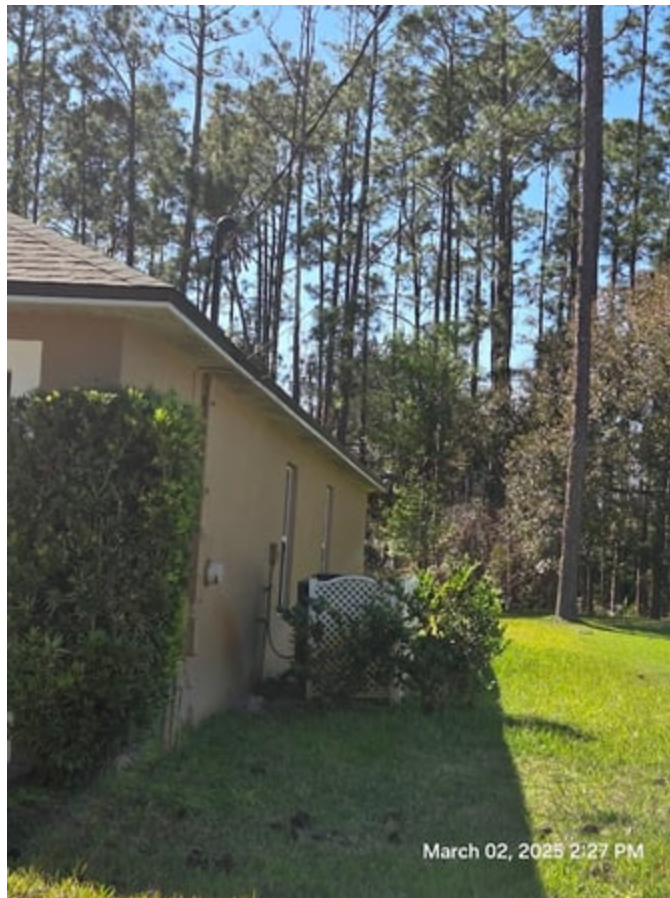
Aerial service live

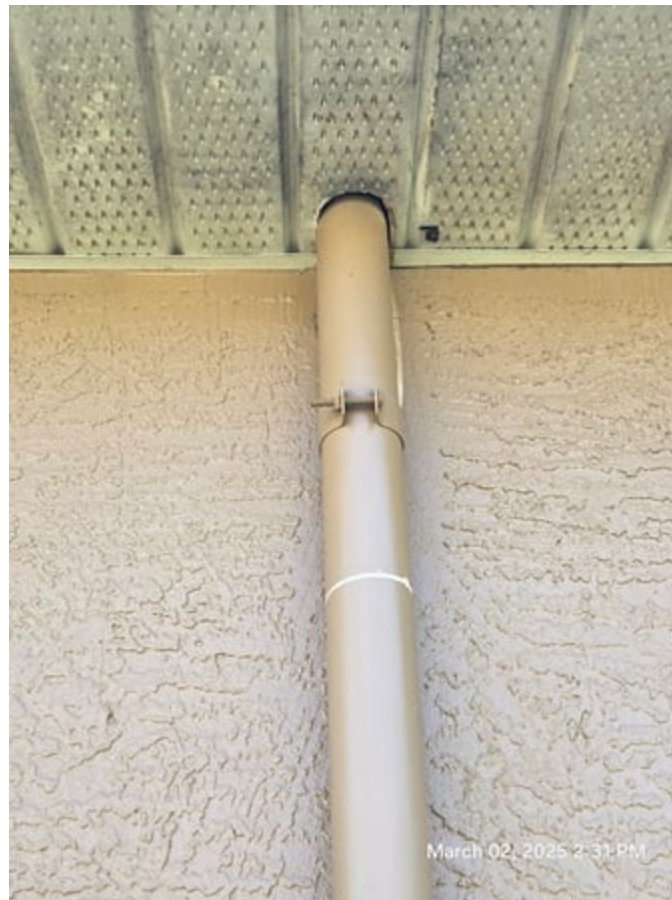
## Service Mast, Service Conduit and Raceway

No Defect(s) Observed

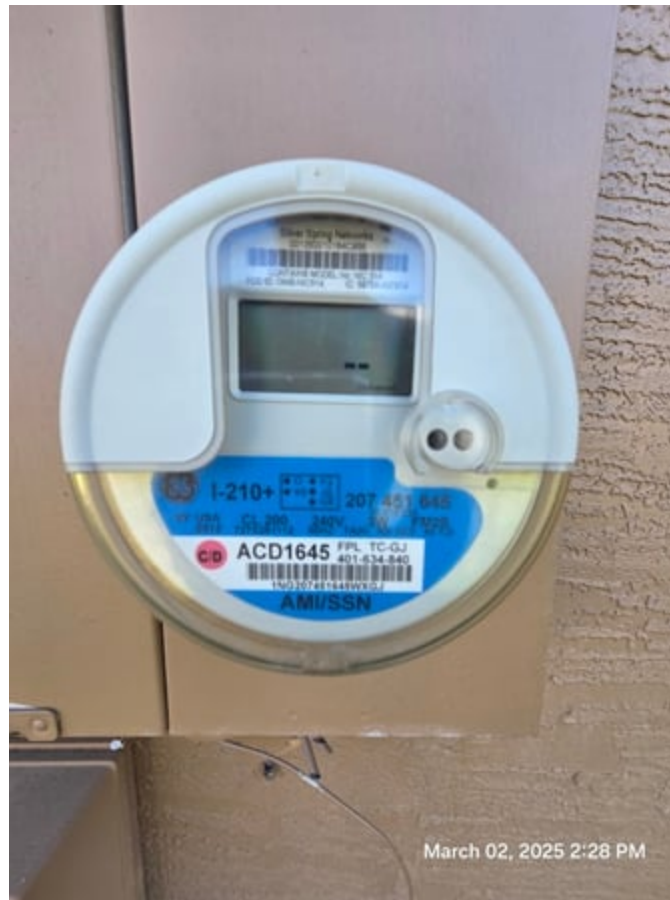
## Electric Meter and Base

No Defect(s) Observed

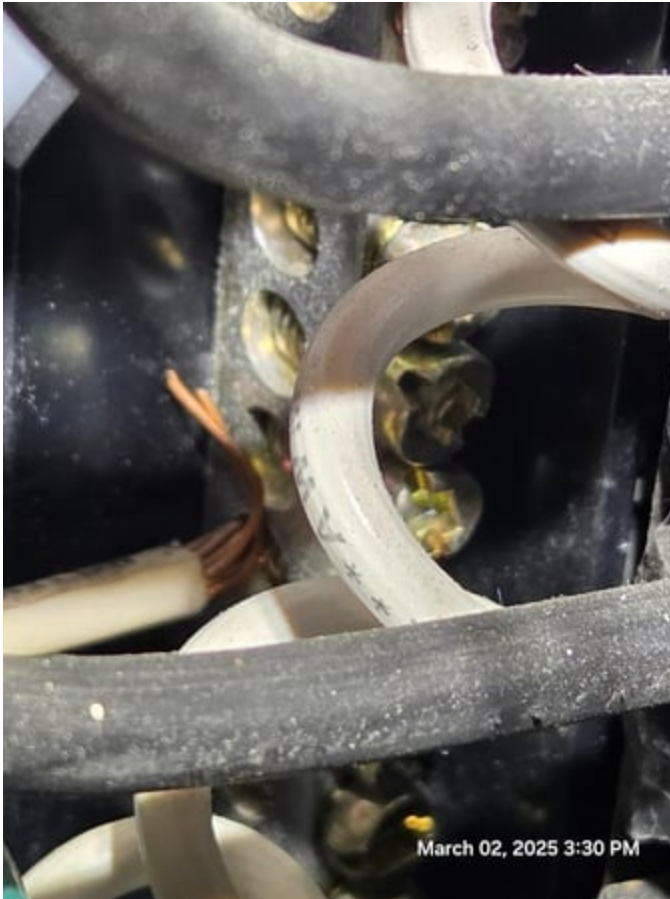
Knock out plug missing. Improperly attached neutral wire. Double stacking of conductors is not permitted on circuit breaker. Recommending contacting a certified electrician.
